August 23, 2021

RE: NRT 21-11 Los Angeles, CA - TCV Failure Analysis  
File C21062

At your request I made an investigation to determine if the flanged collars on the threaded rods of the subject total containment vessel (TCV) failed suddenly as a onetime overload event or if they failed slowly over time and repeated use.

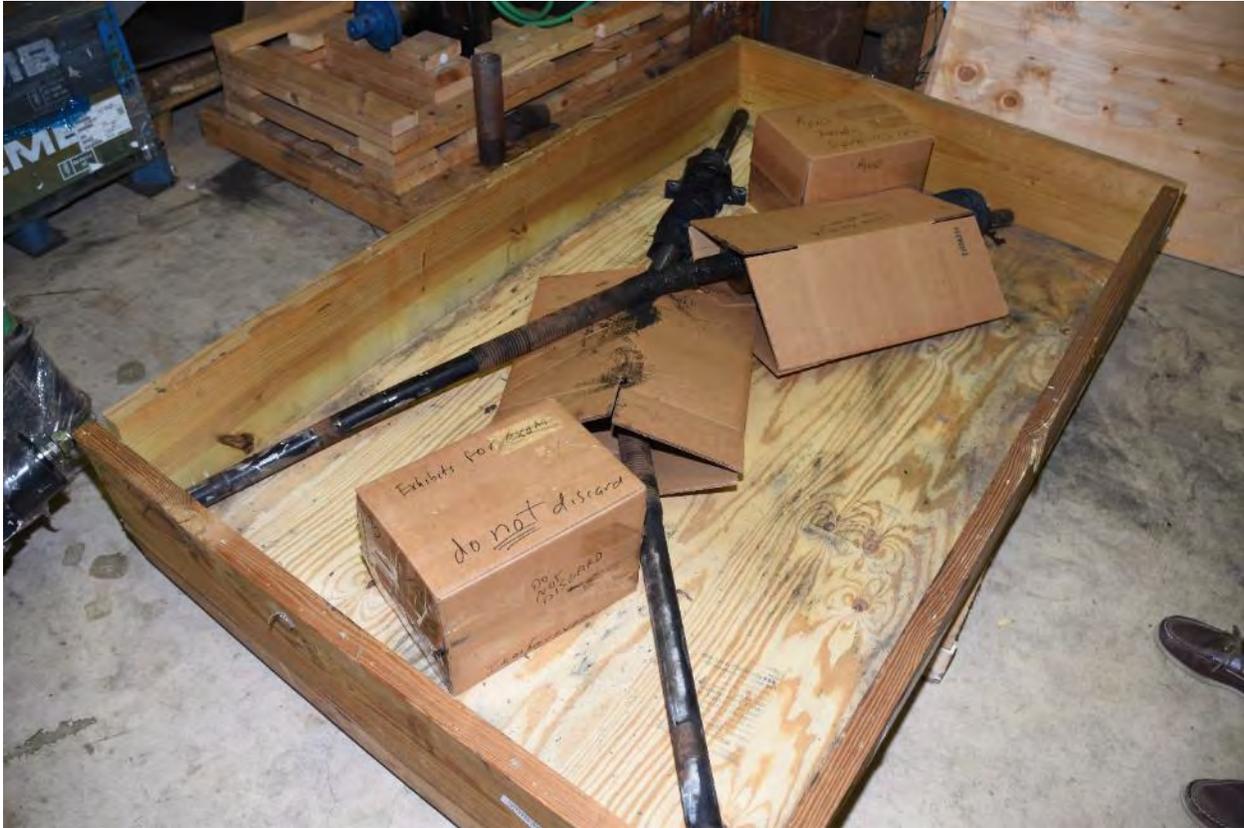
FIGURE 1

The components as received are shown in Figure 1.

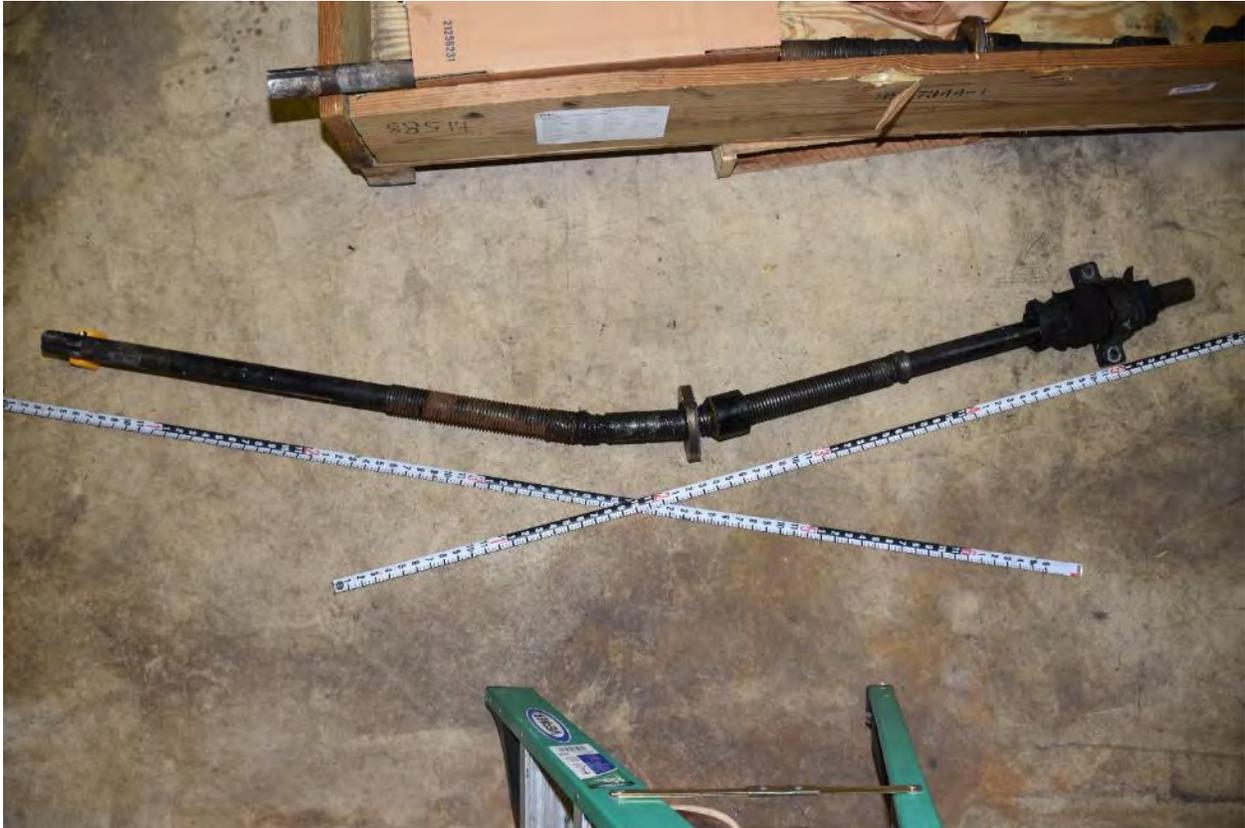
FIGURE 2

The upper threaded rod is shown in Figure 2. Figure 3 shows that the bronze threads of the left (driver's) side flanged collar have been shear off and remain in the threads of the steel rod. Figure 4 shows that the right (passenger's) side flanged collar has broken. The flange is broken away from the rest of the collar. The threads that had been inboard of the flange have been sheared off and remain in the mating threads of the steel rod. The threads of the remainder of the collar are still intact and that portion of the collar turns freely on the steel threaded rod. The flanged collar that had been attached to the top of left side yoke (based on site photographs) is shown in Figures 5 and 6. All the threads have been sheared from this collar, the collar has a crack on a radial-axial plane through one of the bolt holes, and a piece of the collar is broken away.

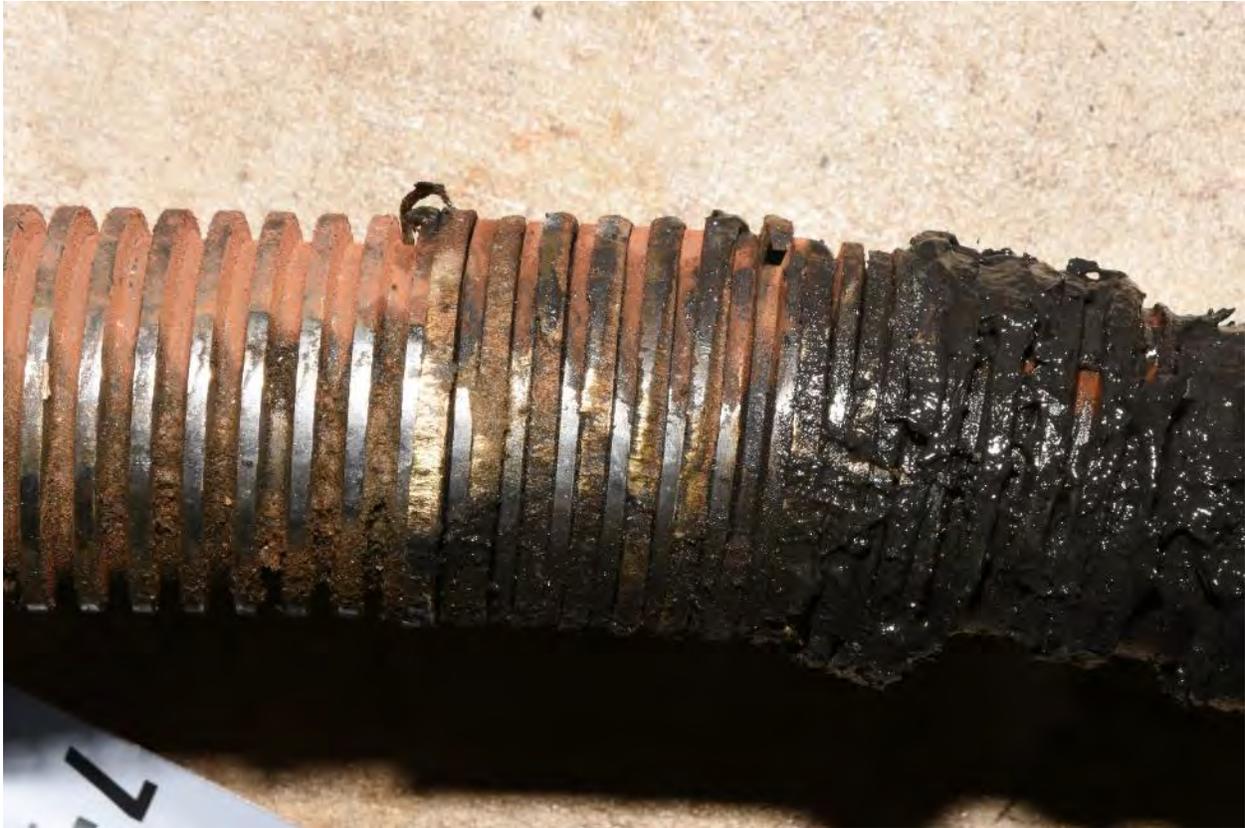
FIGURE 3

The threads were sheared from the left side flanged collar by a force pushing the flanged collars on the yoke to the left. This is consistent with an outward force on the yoke from the explosion having caused the failure at this location. However, the failure of the flanged collars on the right-side were caused by outward force (to the right) attempting to pull the collars from the yoke.

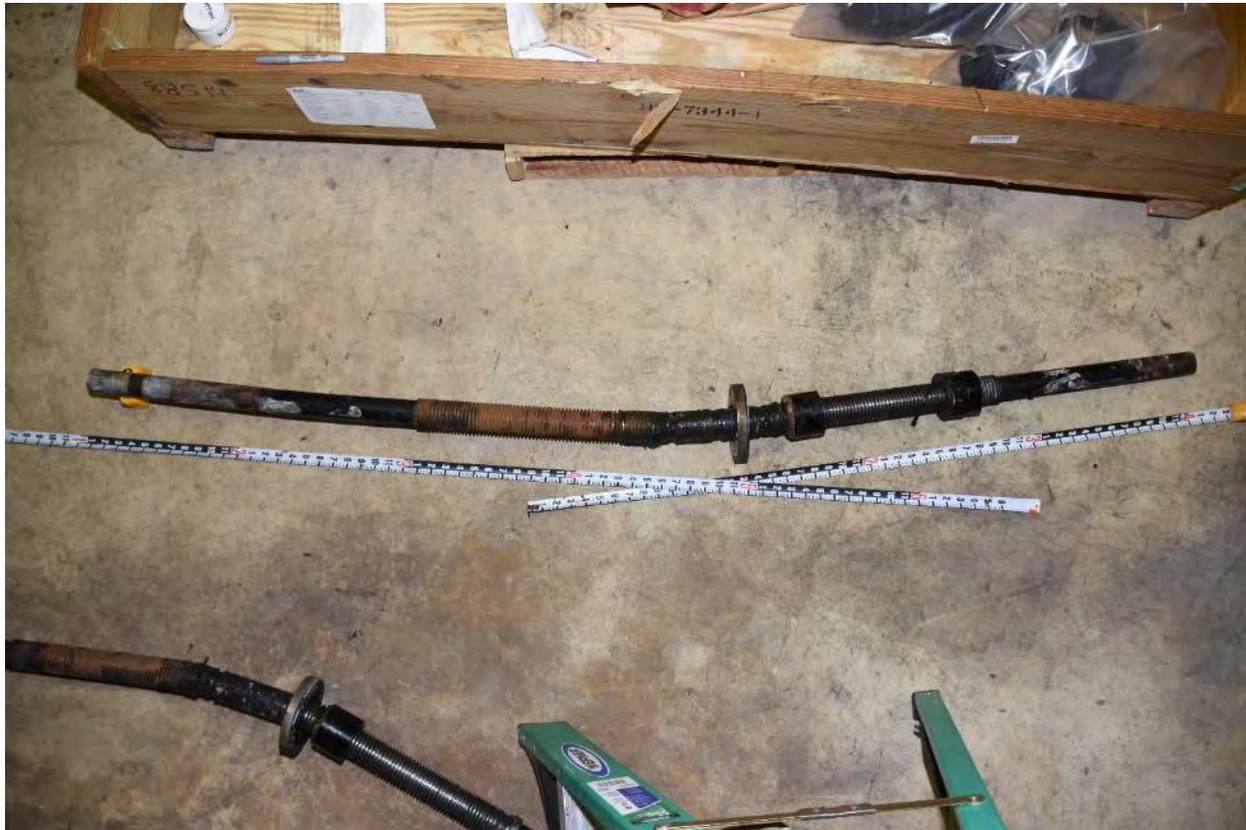
FIGURE 7

The lower threaded rod is shown in Figure 7. Figure 8 shows that the bronze threads of the left-side flanged collar have been sheared off and remain in the threads of the steel rod. Figure 9 shows that the right-side flanged collar has broken. The flange is broken away from the rest of the collar. The threads that had been inboard of the flange have been shear off and remain in the mating threads of the steel rod. The threads of the remainder of the collar are still intact and that portion of the collar turns freely on the steel threaded rod. The flanged collar that had been attached to the bottom of left side yoke (based on site photographs) is shown in Figures 10 and 11. All the threads have been sheared from this collar and the collar has a crack on a radial-axial plane through one of the bolt holes.

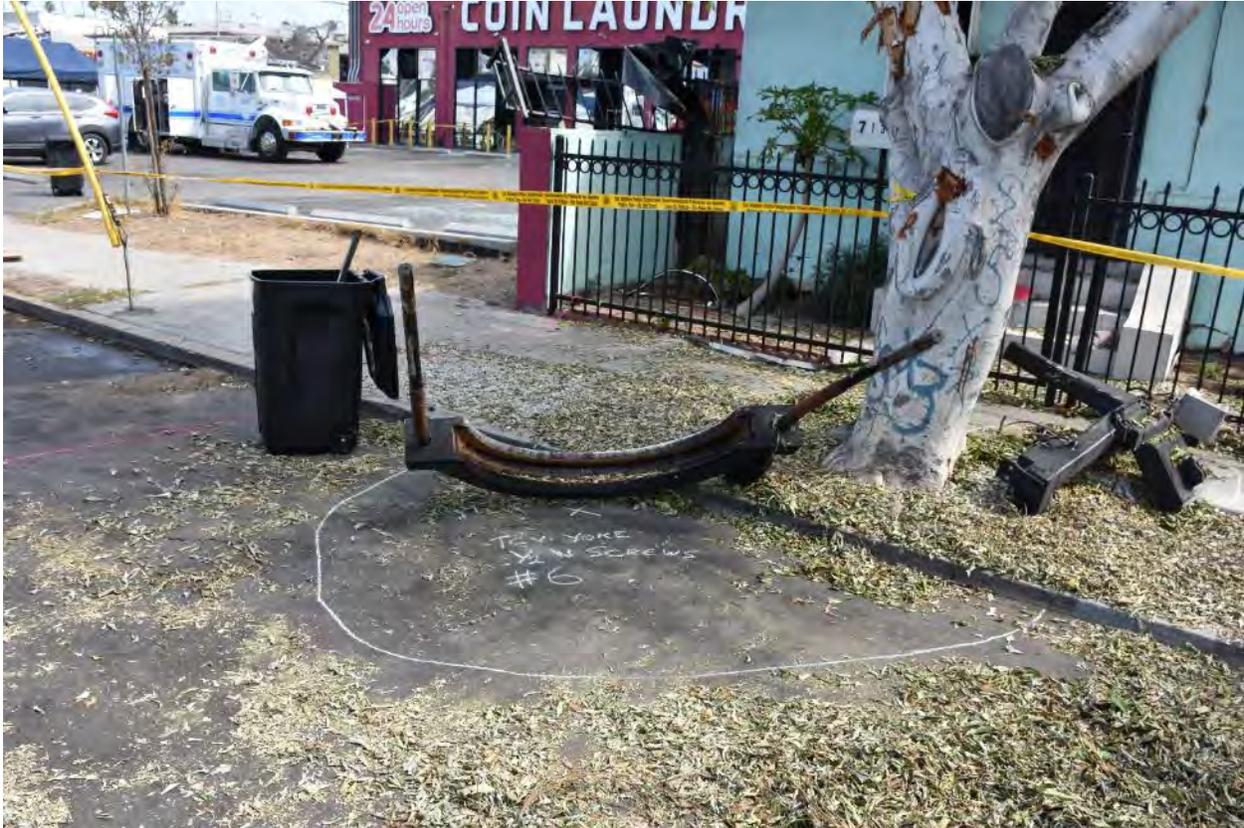
FIGURE 12

A scene photograph reproduced as Figure 12 shows that the threaded rods remained with the right-side yoke. The scene photographs reproduced as Figures 13 and 14 show that the left-side yoke has separated from the threaded rod and struck an automobile.

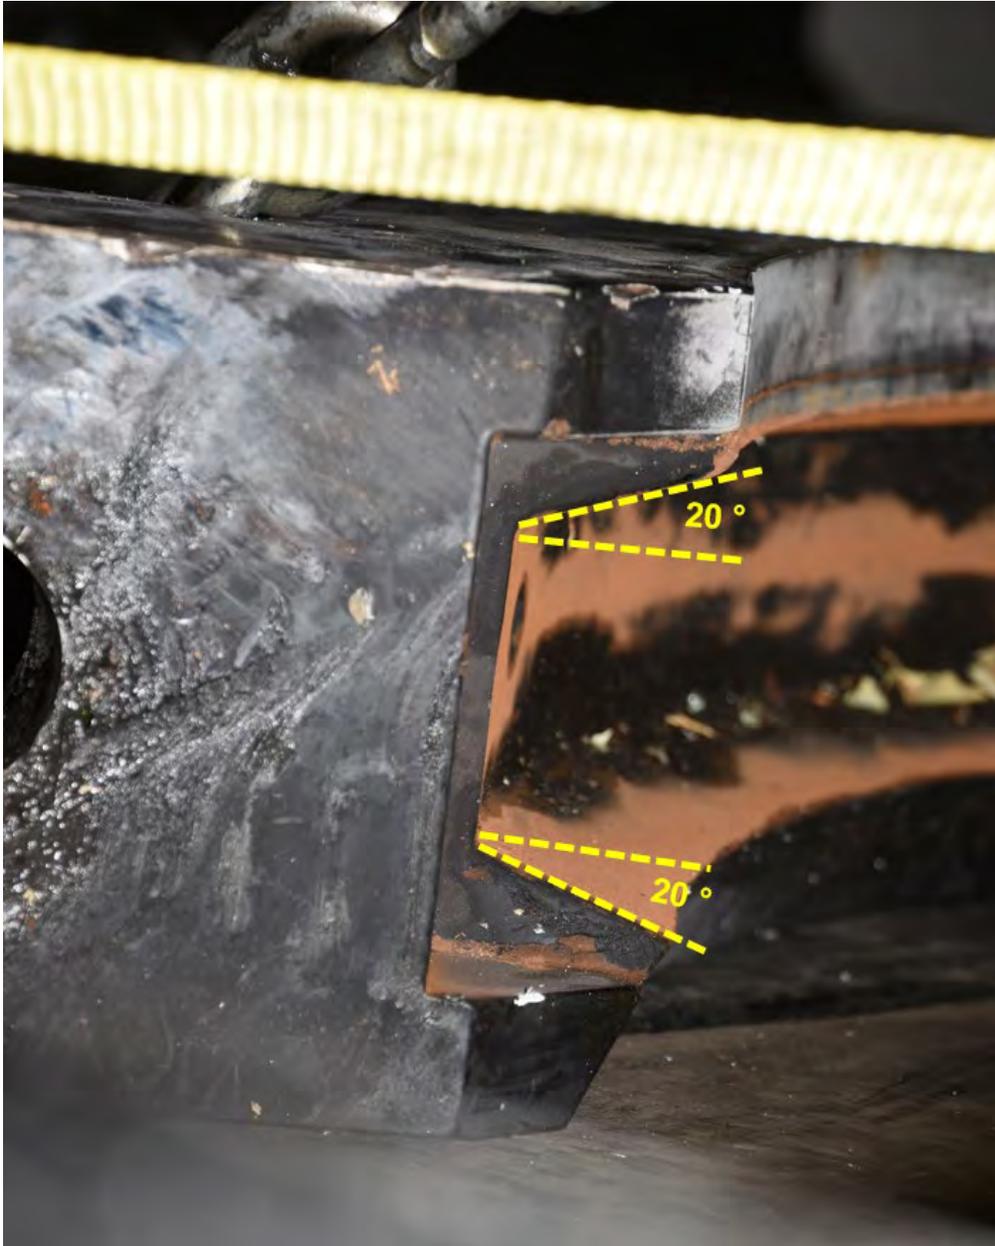
FIGURE 15

As shown in the image of the harden steel insert in the yoke of Figure 15, the clamping surface between the vessel and door flanges and the yoke surface is sloped at approximately 20 degrees from the plane of the door. This results in part of the outward explosion force on the door being directed radially outward against the yokes and part of that load is carried by the flanged collars on the threaded rods.

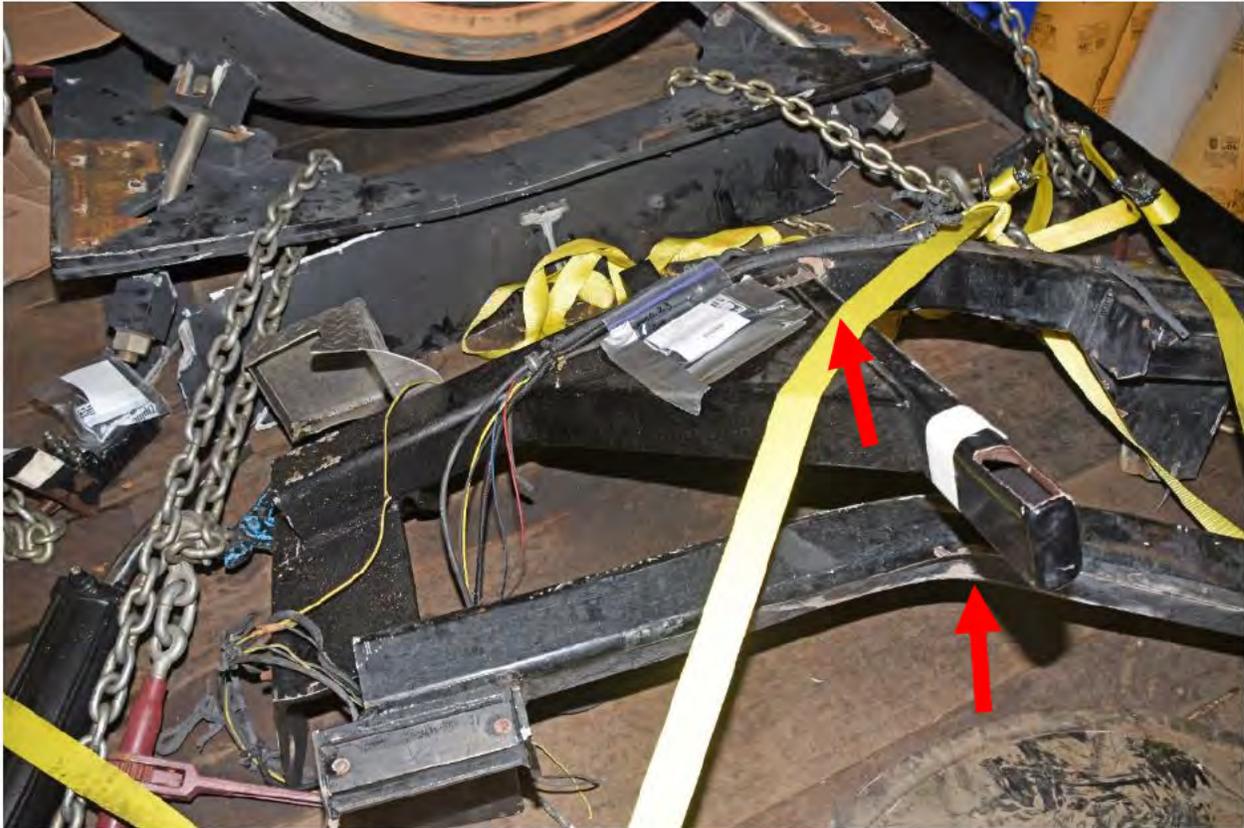
FIGURE 16

Examination of evidence at the ATF Los Angeles facility showed that the vertical columns of the vessel support structure had been bent severely outward by impact from the yokes as they travelled laterally away from the door. This is indicated by the red arrows on Figure 16. The corresponding impact witness marks on the yokes are shown in Figures 17 and 18.

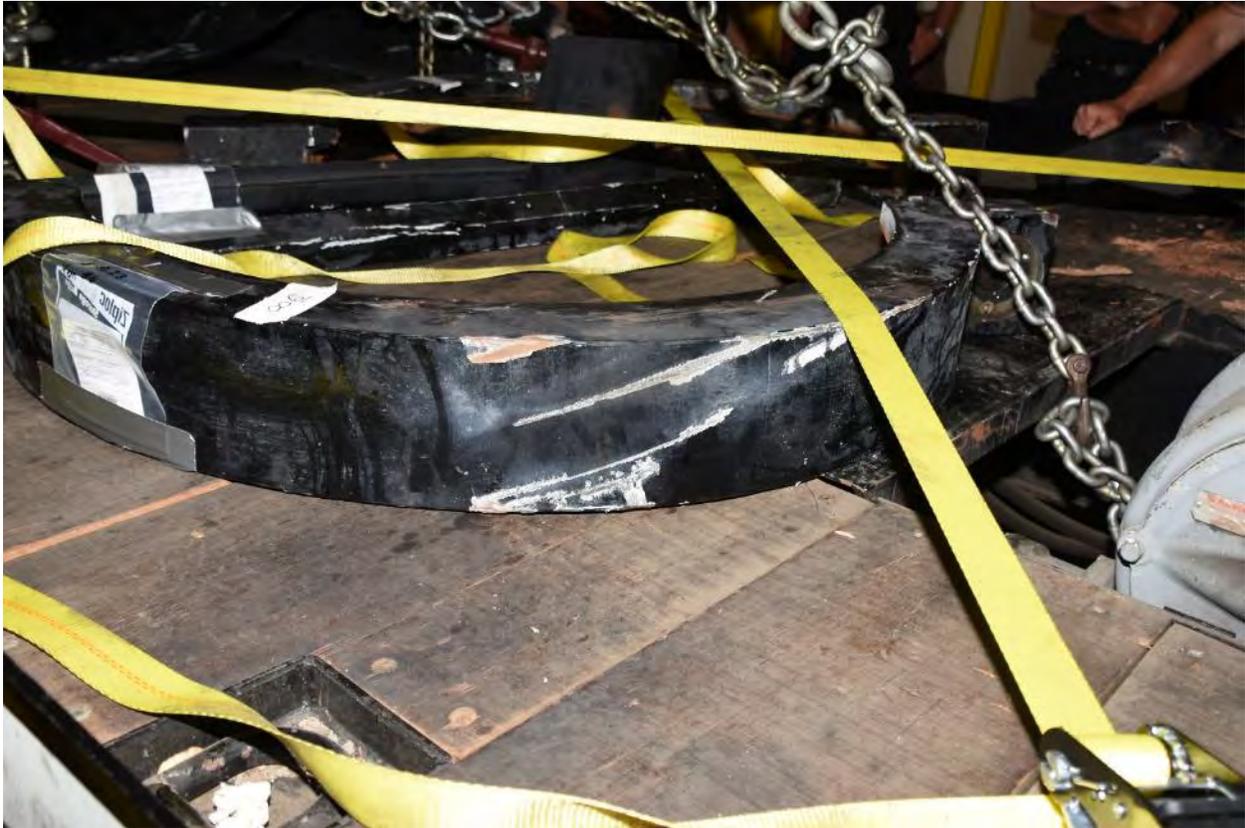
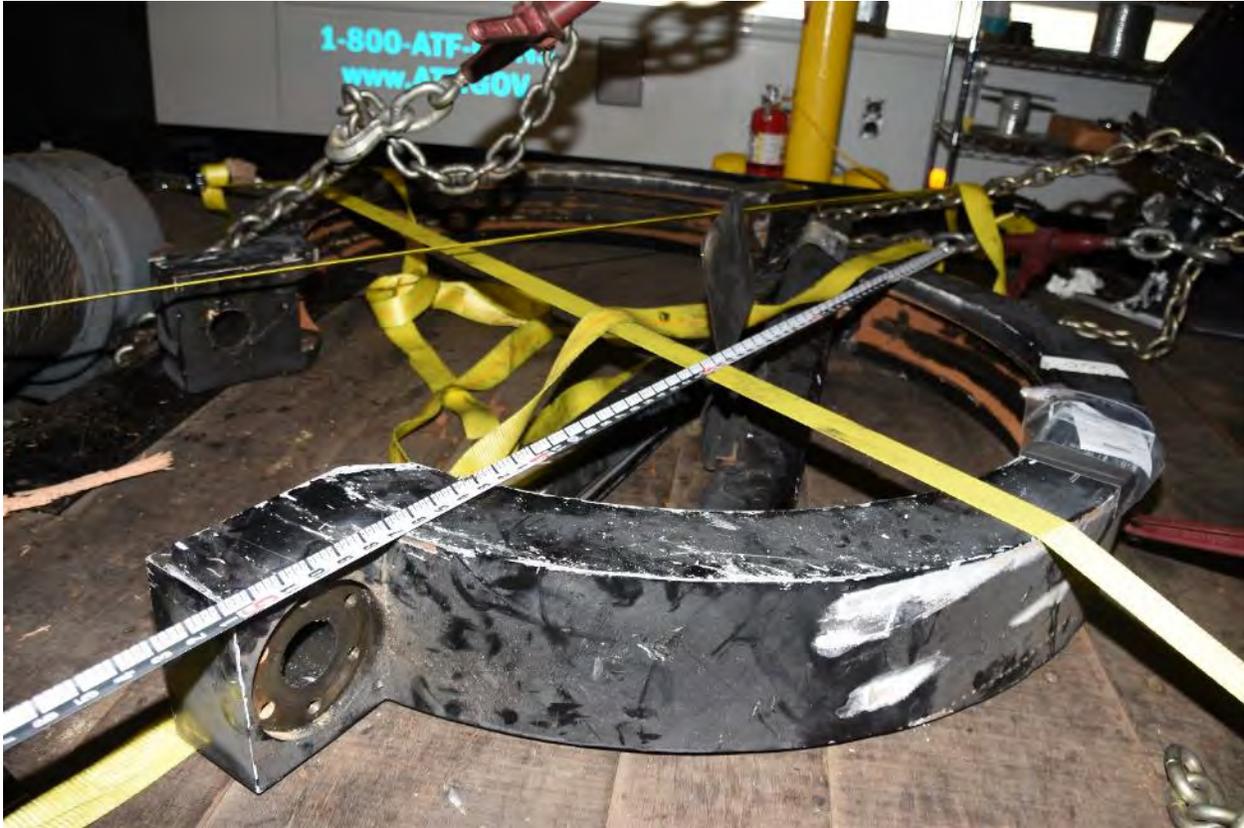
When the flanged collars on the left side yoke failed, the left-side yoke began traveling to the left off the threaded rods and the right-side yoke began traveling to the right with the threaded rods attached. When the right-side yoke struck the support structure column on the right, the yoke was slowed down while the momentum of the threaded rod acted to keep the rods moving to the right. This created the load on the flanged collars that broke collars away from the flanges and sheared the threads under the flanges.

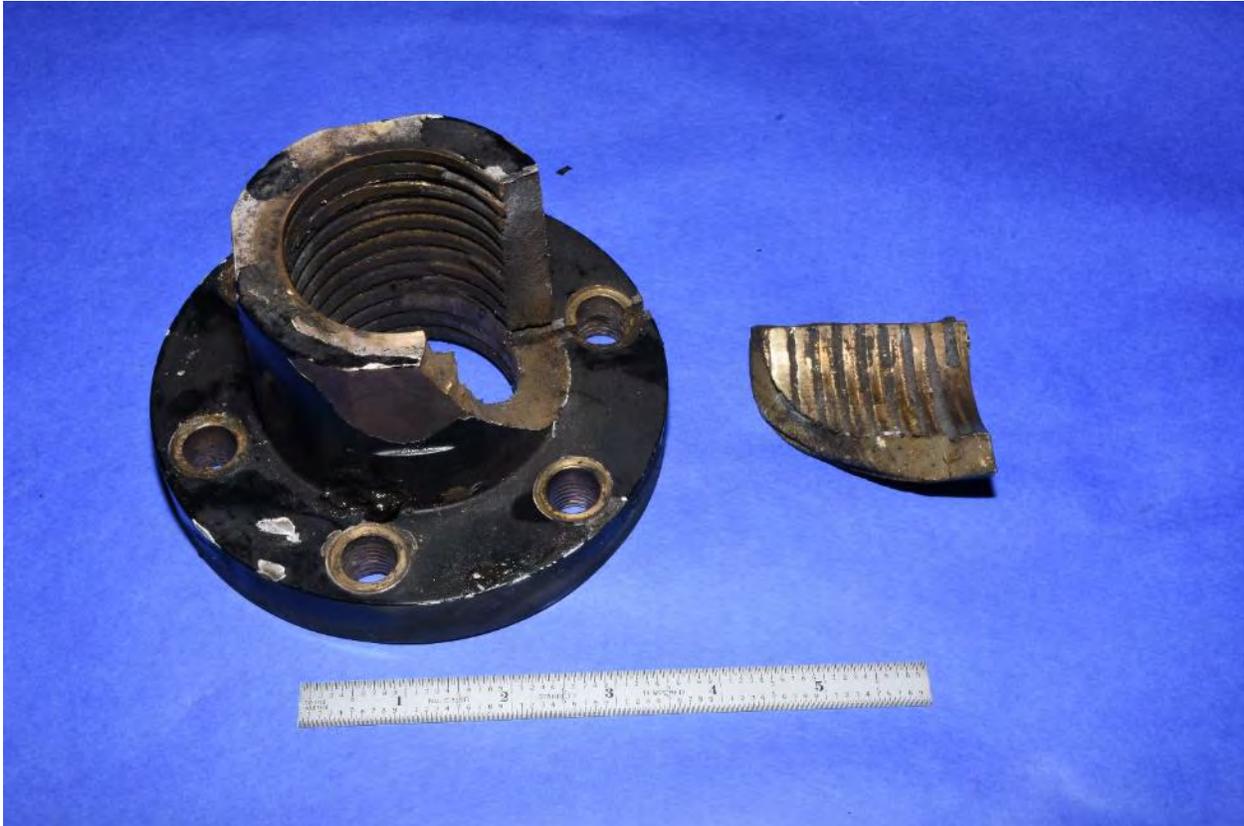
FIGURE 19

The top left-side flanged collar is shown in Figure 19. It was sectioned to facilitate direct examination of the longitudinal fracture and to obtain a section through the sheared threads for metallographic examination as shown in Figure 20.

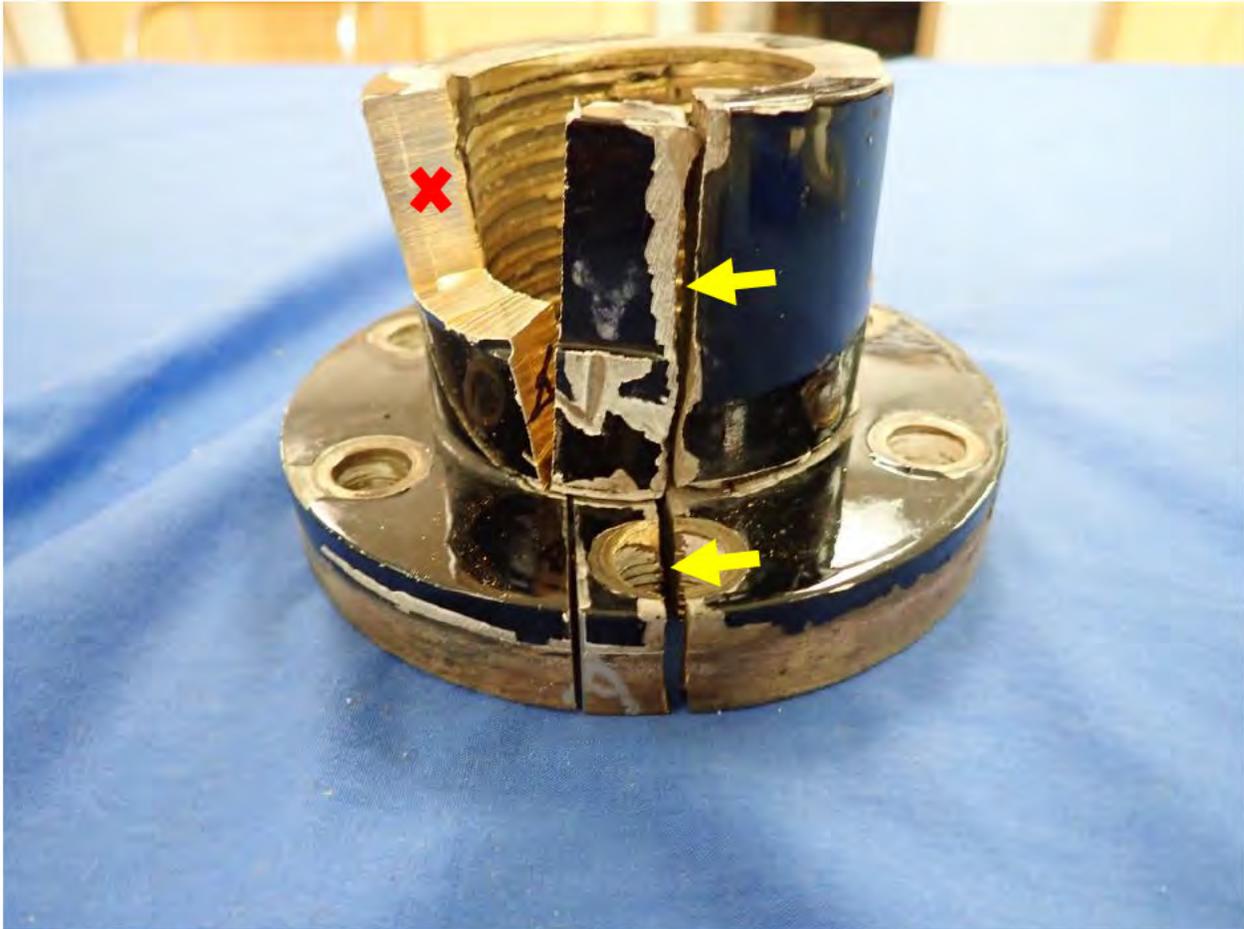
FIGURE 20

The fracture surfaces indicated by the yellow arrows on Figure 20 are shown in the stereo microscope images of Figure 21. The fracture appears to be a onetime overload fracture starting at the bolt hole in the flange. The black arrows show the fracture propagation direction.
