August 23, 2021

RE: NRT 21-11 Los Angeles, CA - TCV Failure Analysis  
File C21062

At your request I made an investigation to determine if the flanged collars on the threaded rods of the subject total containment vessel (TCV) failed suddenly as a onetime overload event or if they failed slowly over time and repeated use.

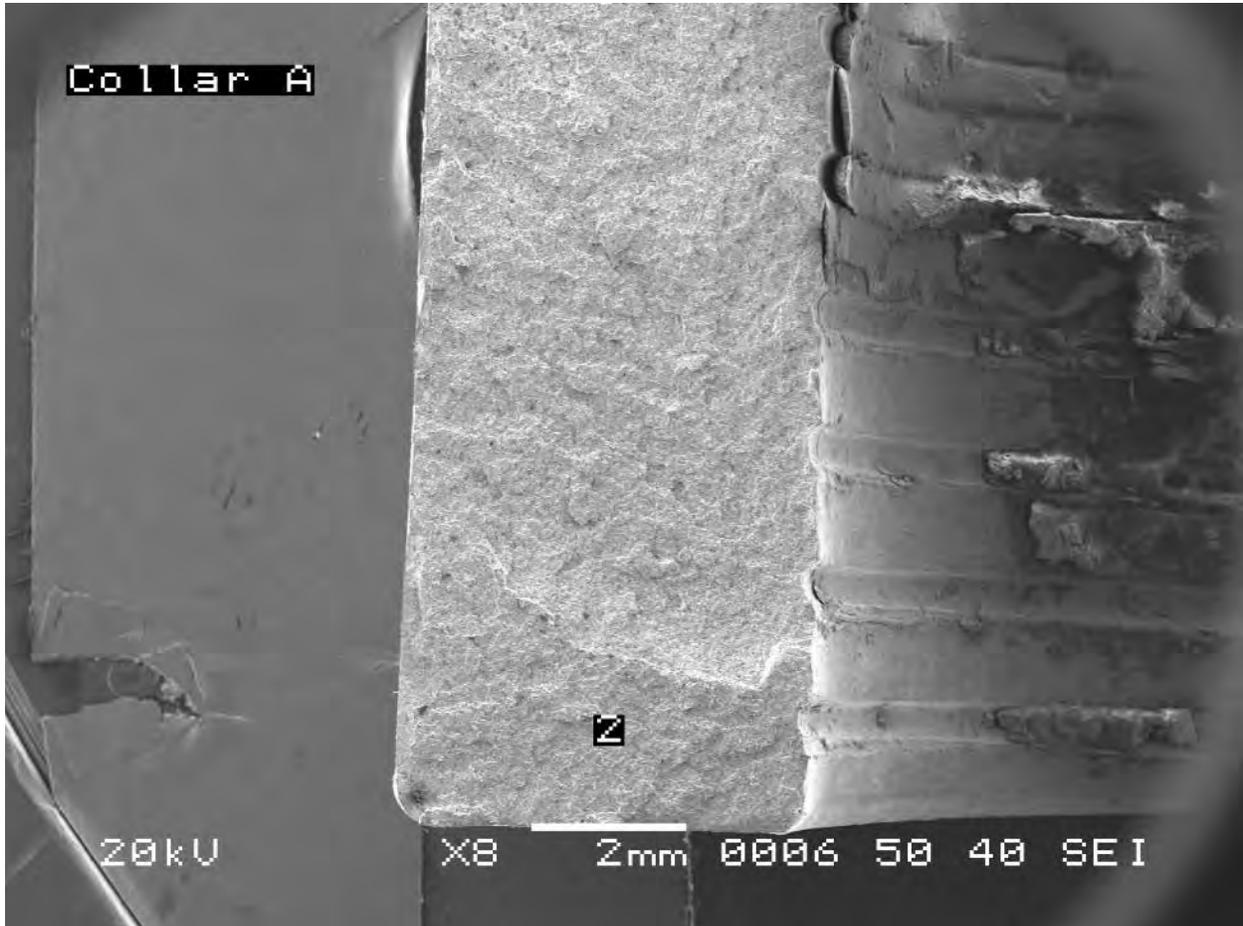
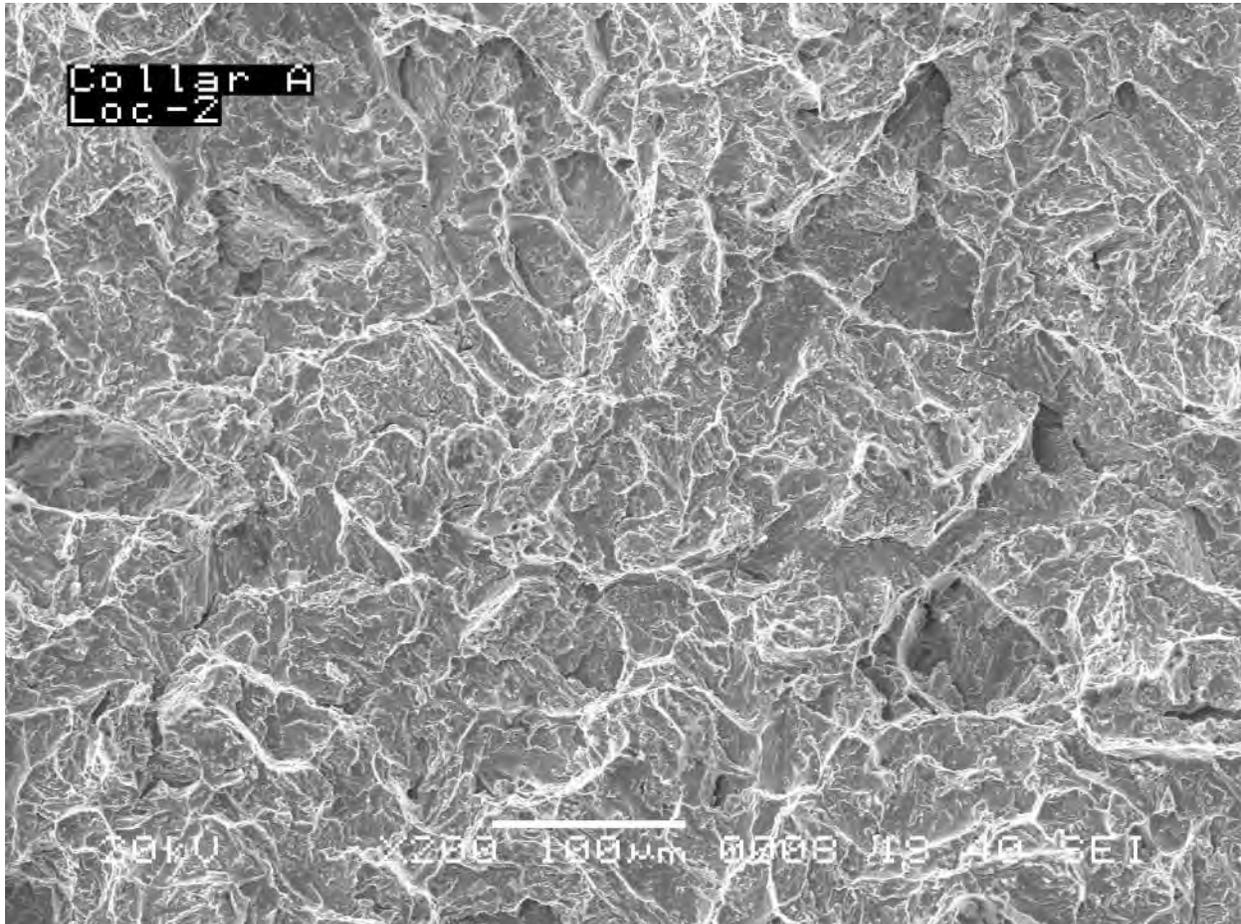
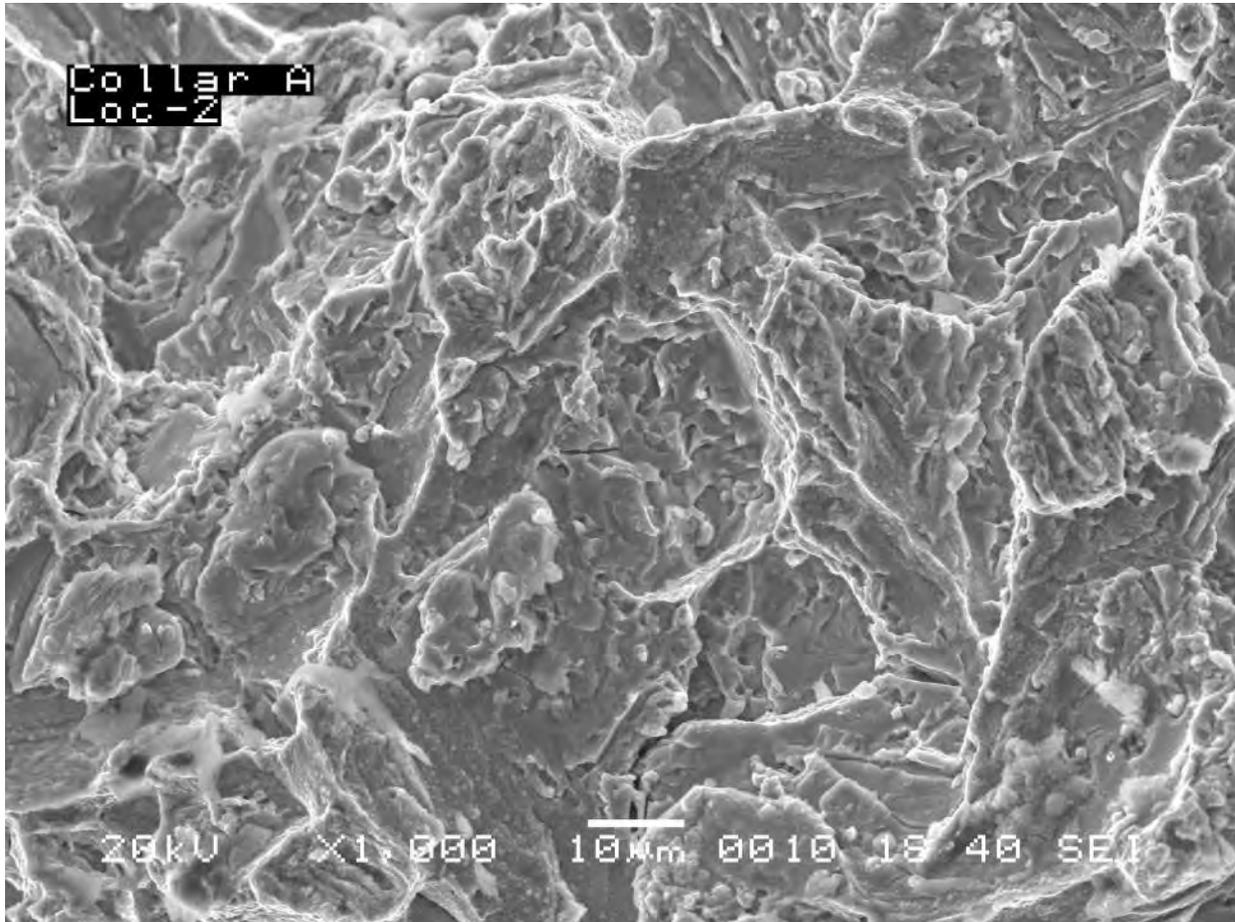
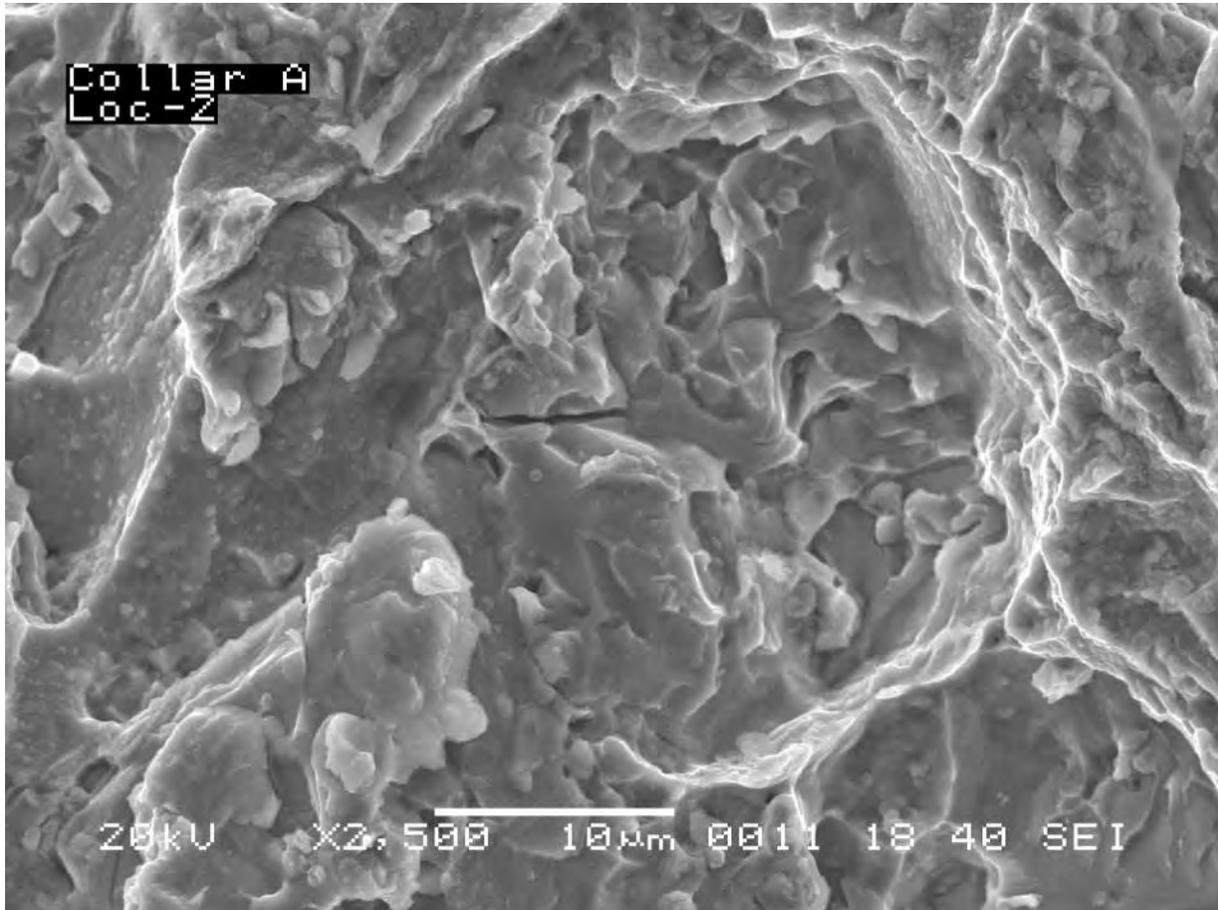
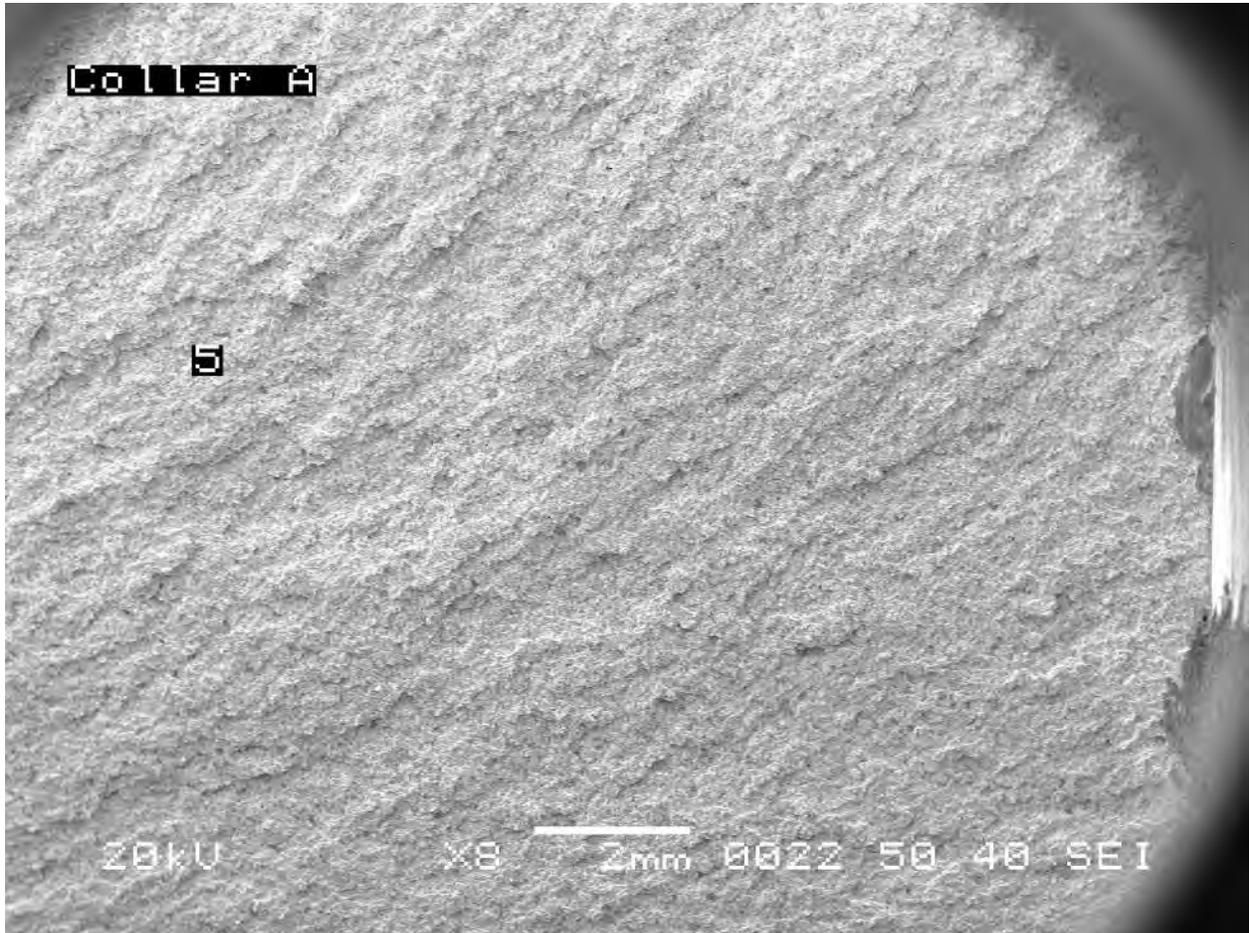
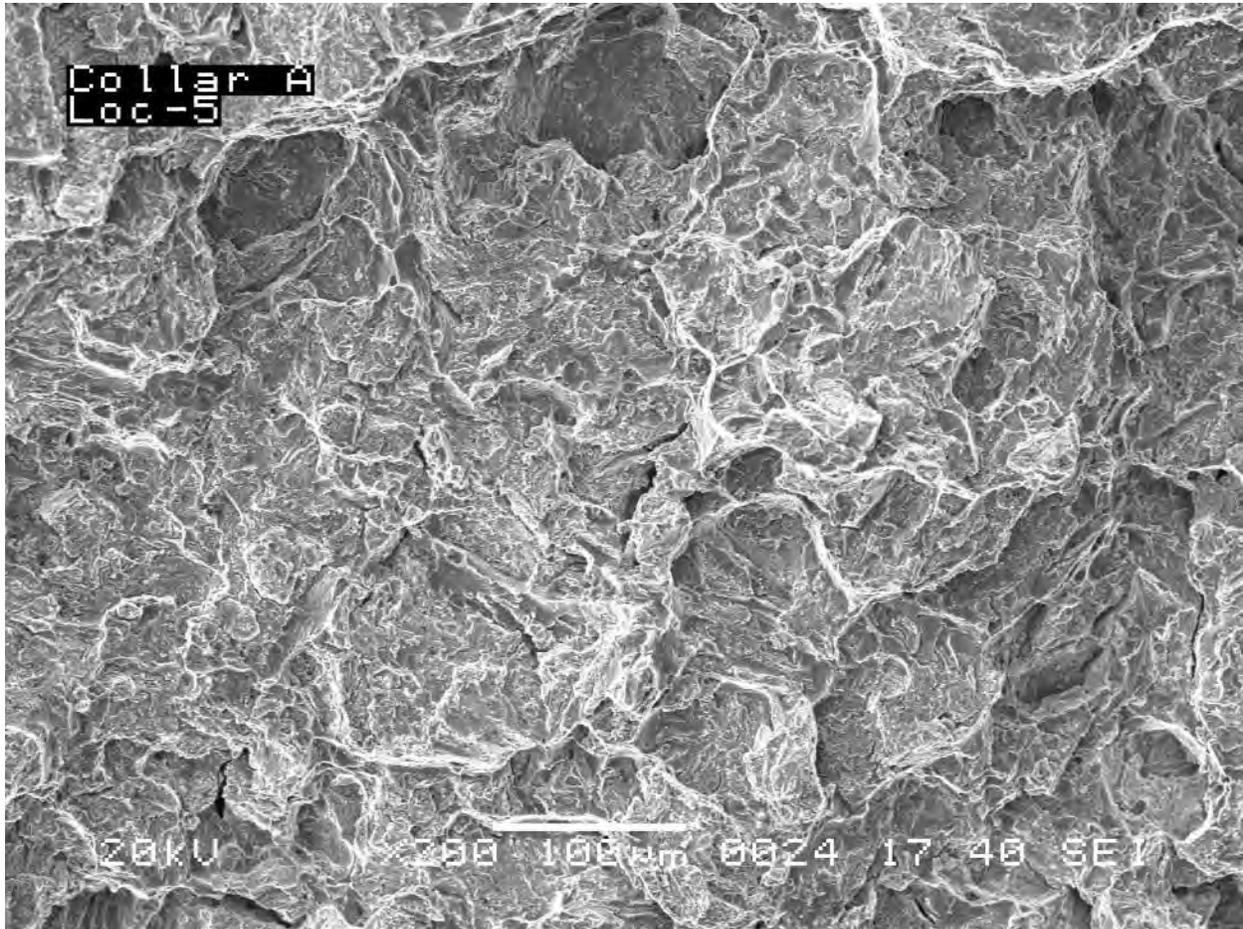
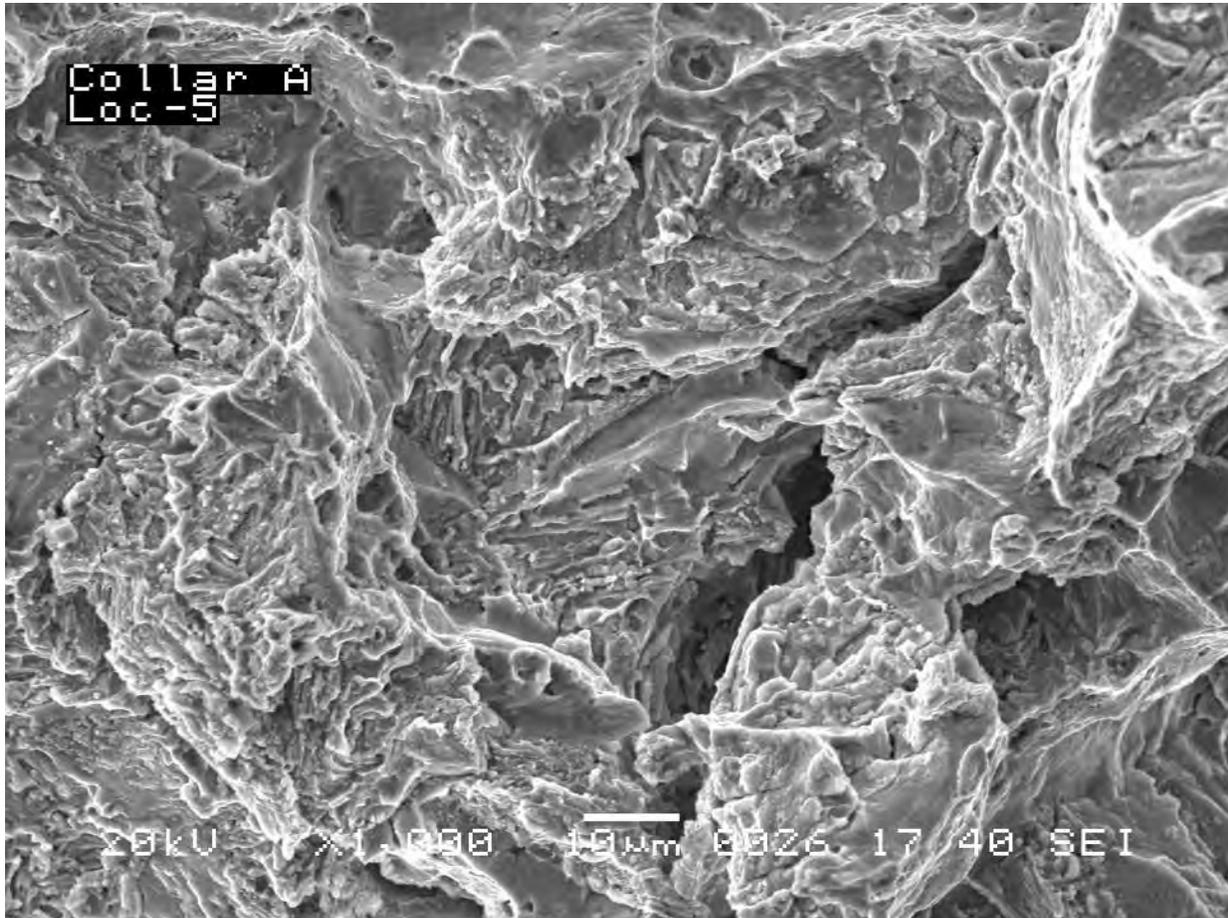
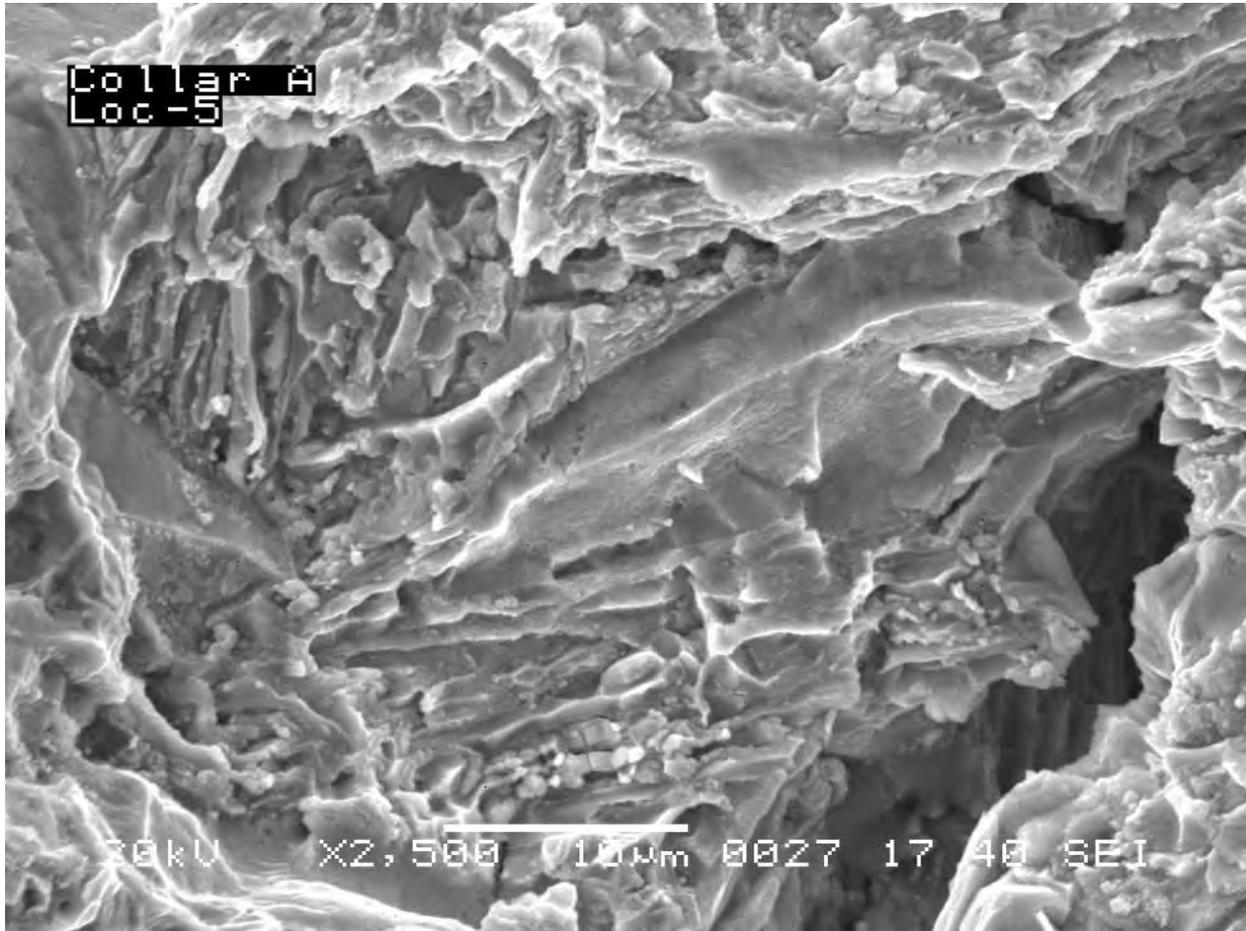
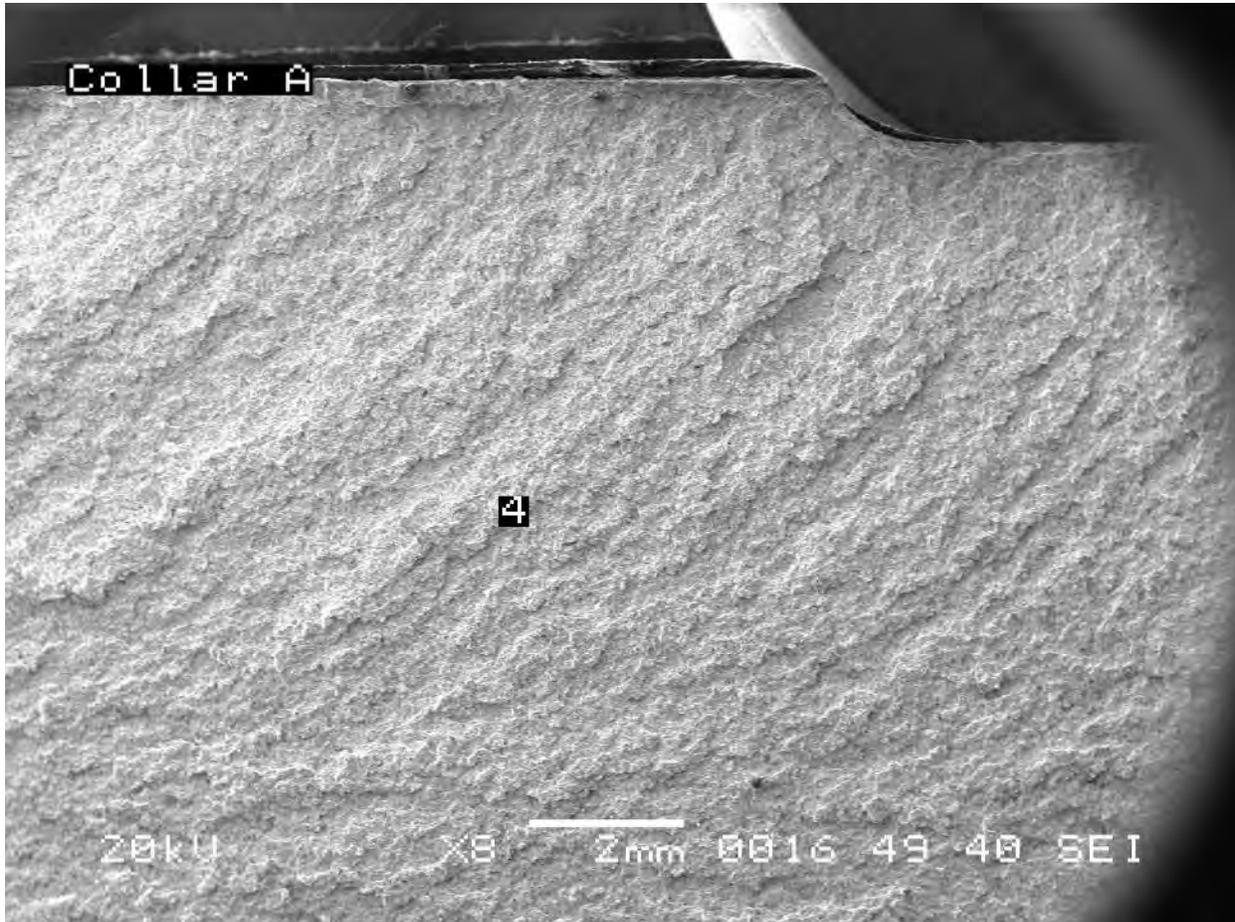
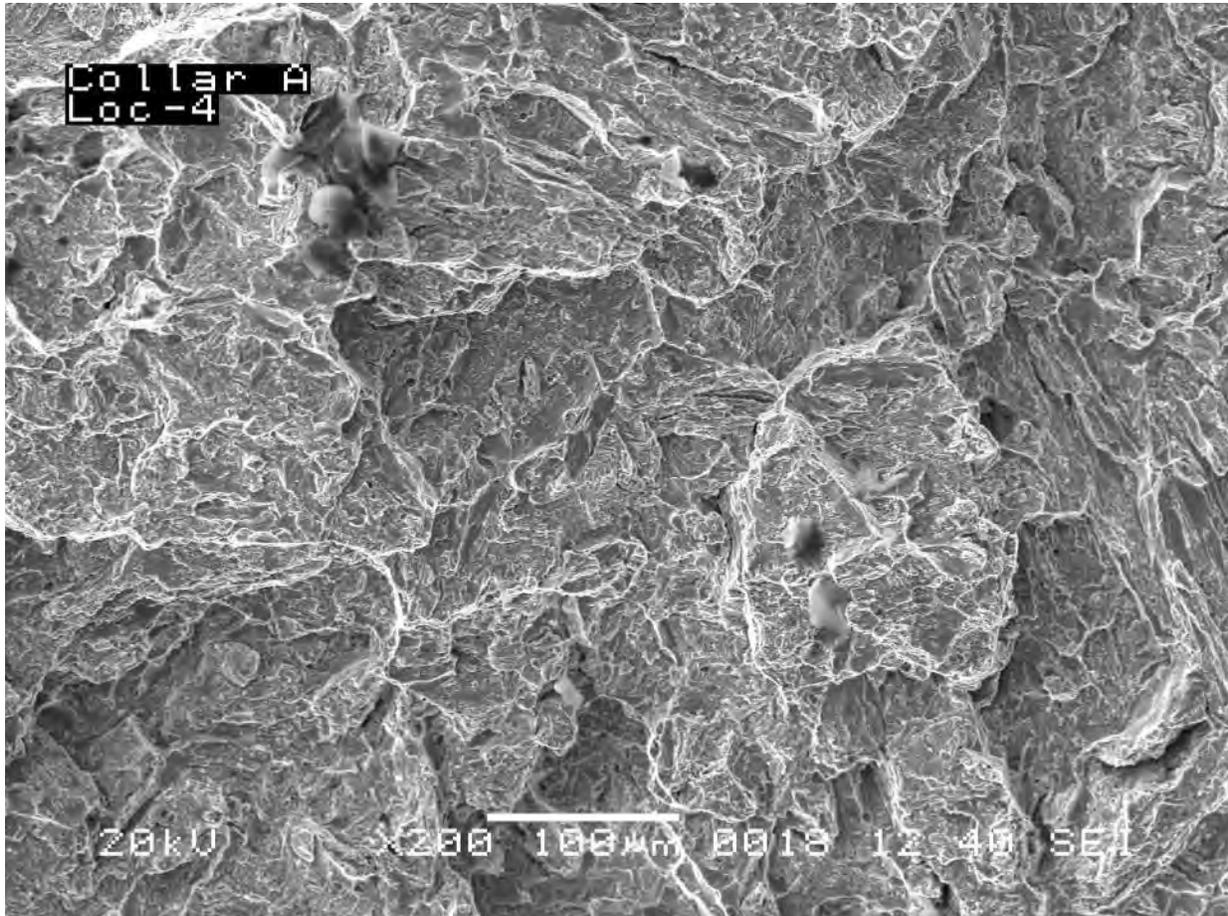
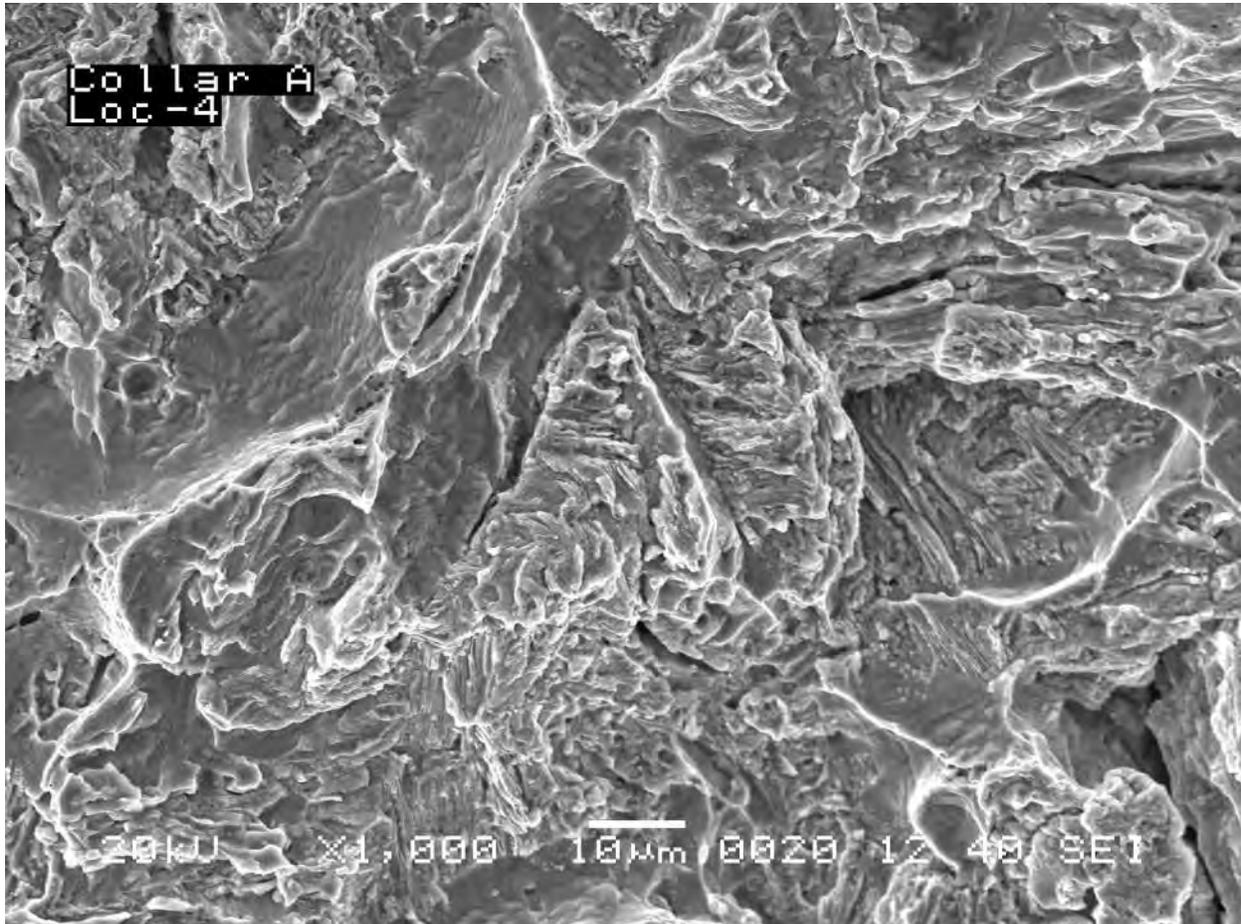
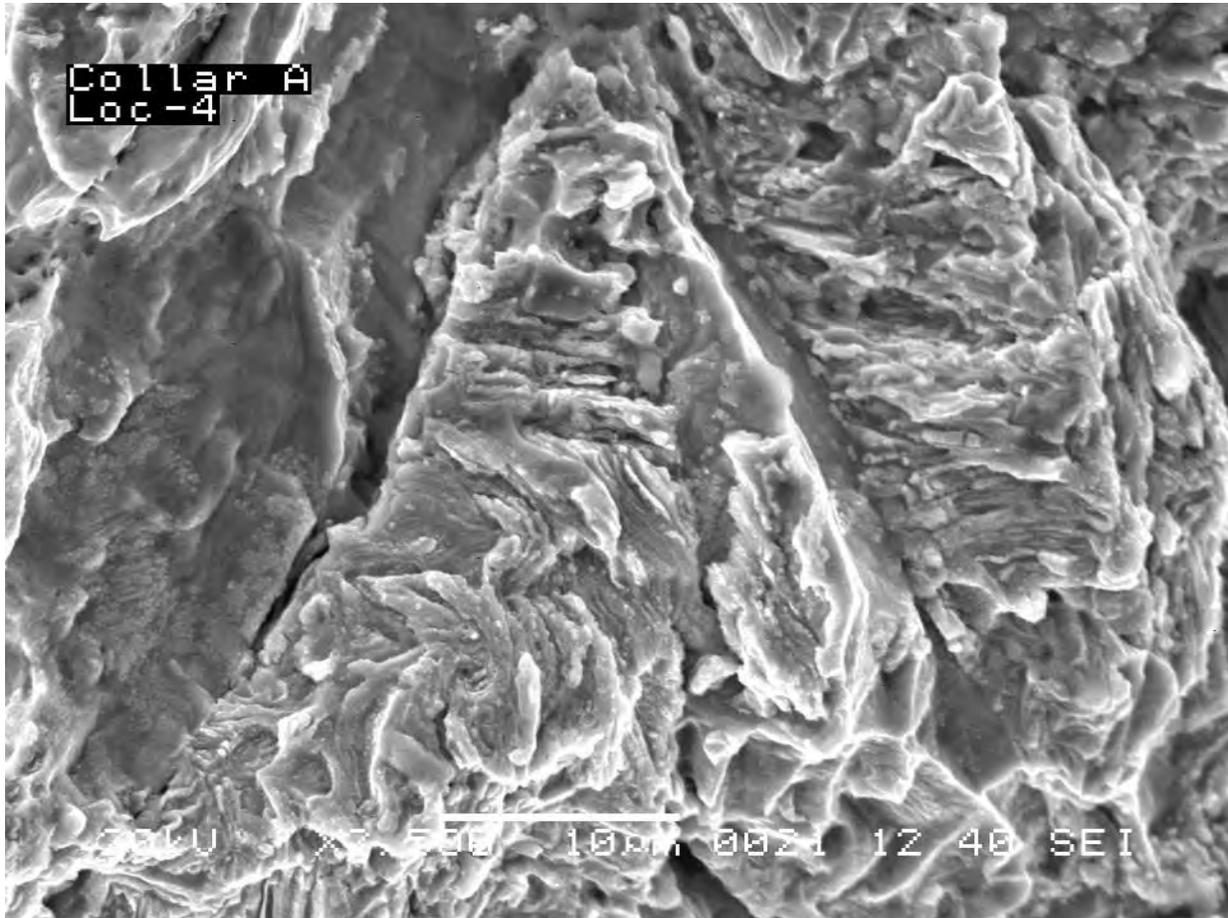
The fracture was examined with the scanning electron microscope (SEM). SEM images obtained at Location 2, 5, and 4 (on Figure 21) are shown in Figures 22 through 33. These images show a mostly brittle, onetime overload fracture morphology. This confirms that the fracture occurred as a onetime, rapid event and that there was no prior slow crack growth.

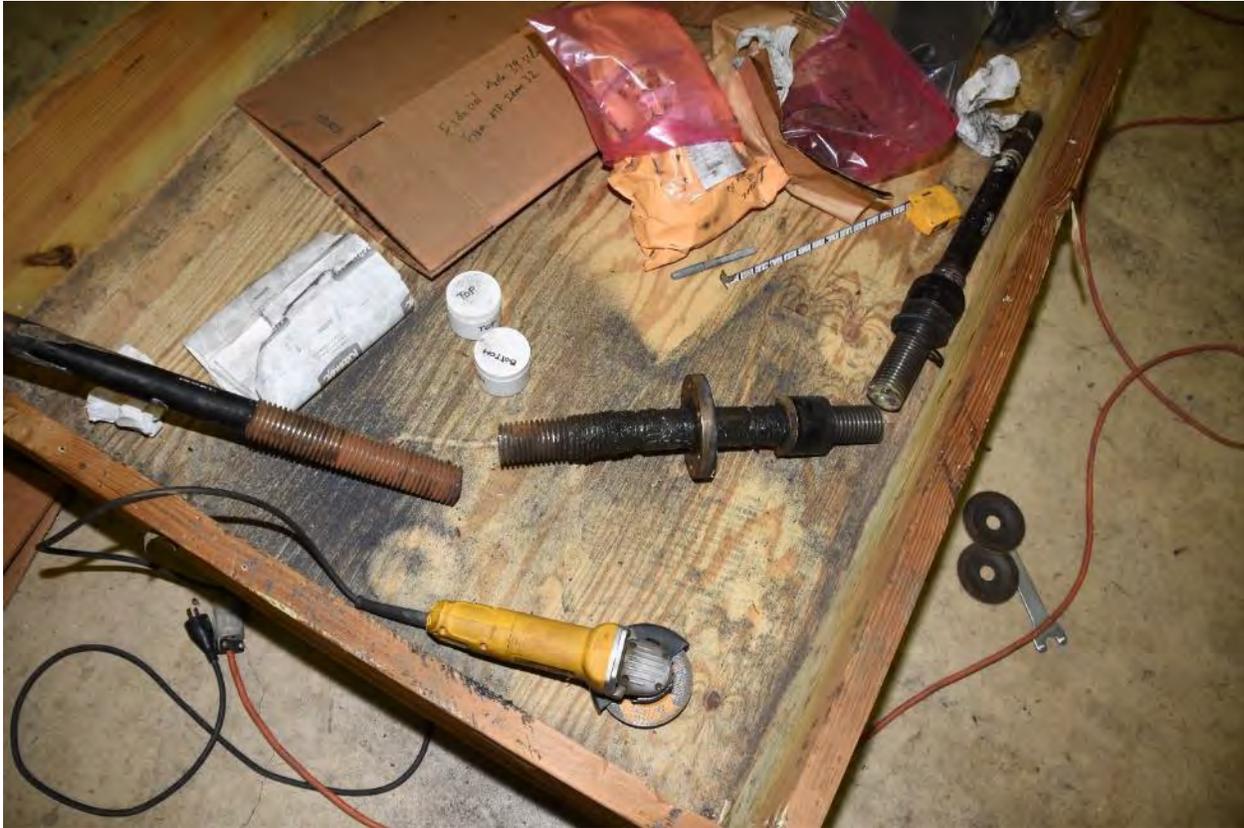
FIGURE 34

It was noted that the collars of the broken flanged collars on the right-side still rotated smoothly on the threaded rods. To remove one of these collars and to facilitate cleaning of the threaded rod, a section was cut from the bottom threaded rod as shown in Figure 34.

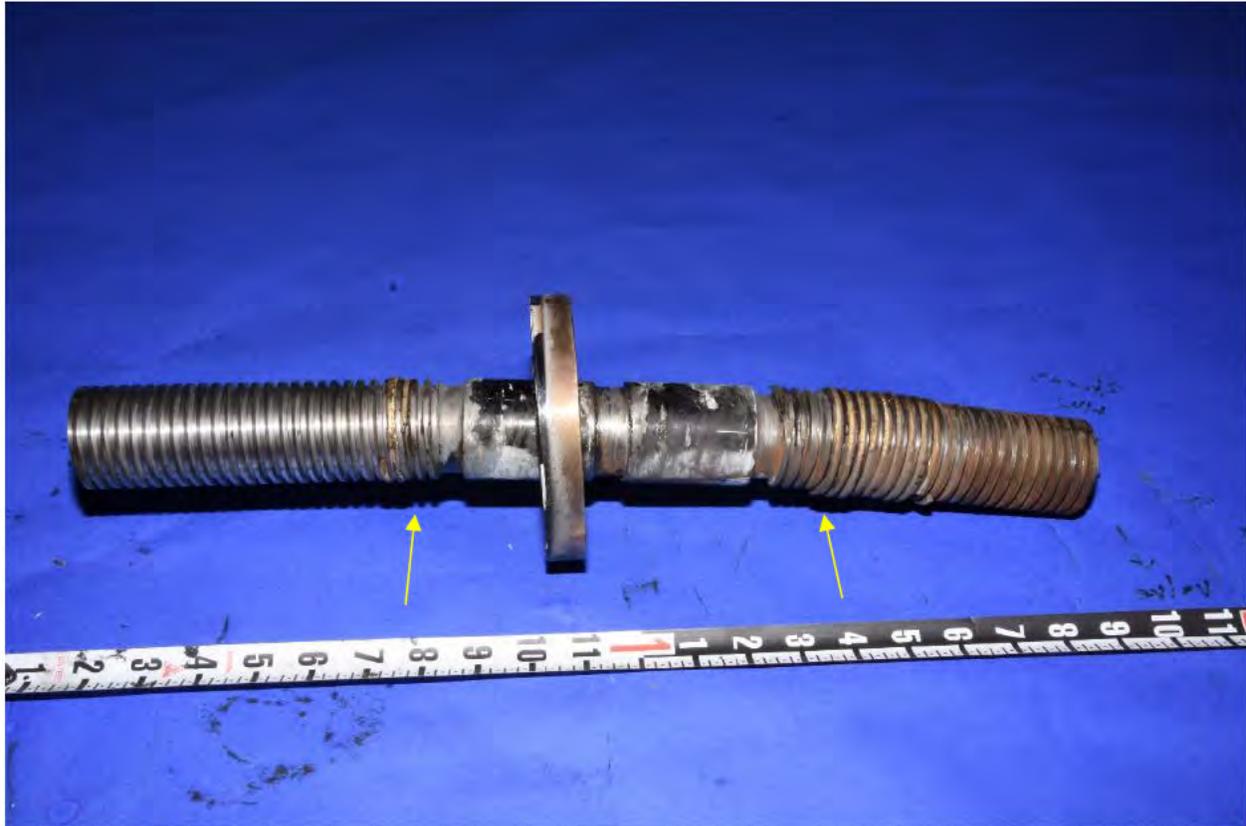
FIGURE 35

The removed section of the bottom threaded rod after degreasing is shown in Figure 35. The sheared off collar threads are visible. The distance between where the threads were sheared off is consistent with the yokes having been in the fully closed position when this occurred. The threads which sheared off the left-side flanged collar are shown in Figures 36 and 37. The threads which had sheared off from the flange on the right-side are shown in Figures 38 and 39. This type of shear failure of entire threads does not occur slowly over time; it occurs as a rapid onetime event. The longitudinal break in the threads visible in Figure 37 shows that the longitudinal cracking of the collar occurred slightly before the threads were completely sheared off.

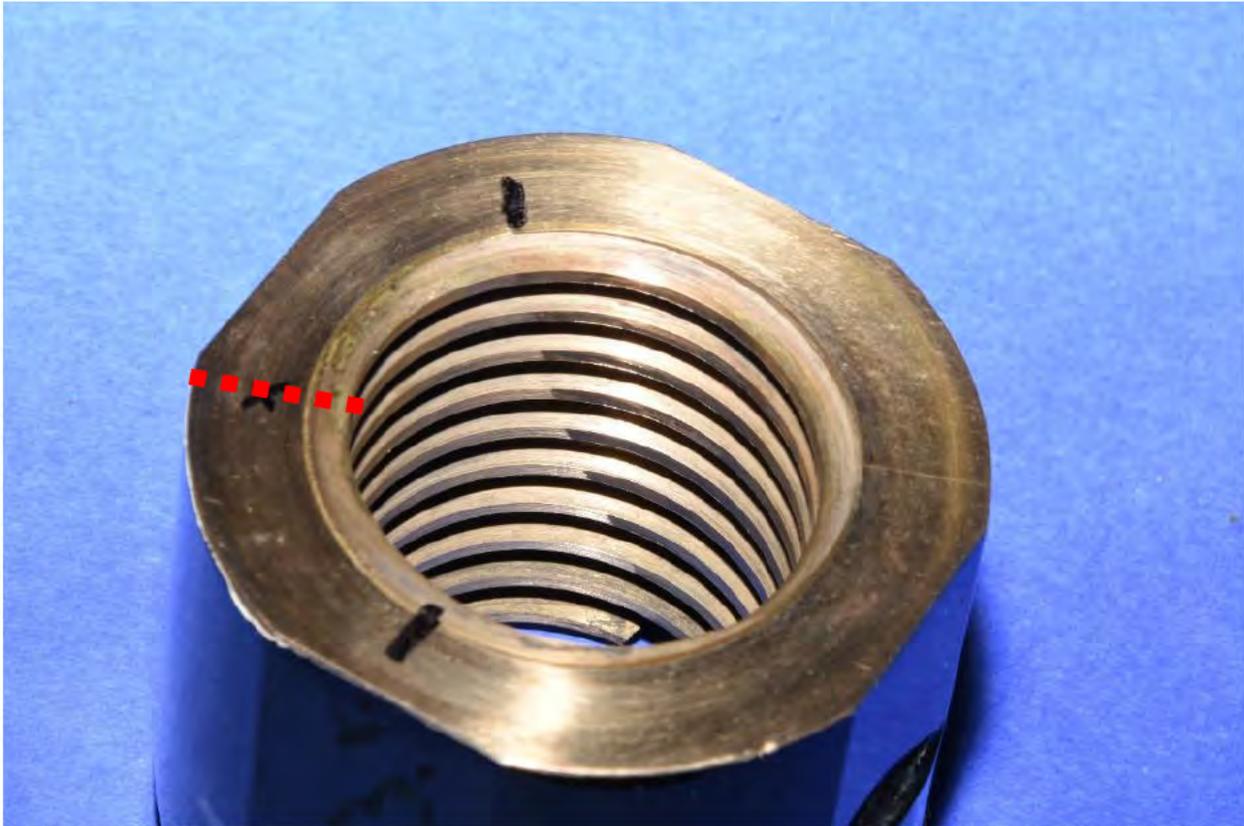
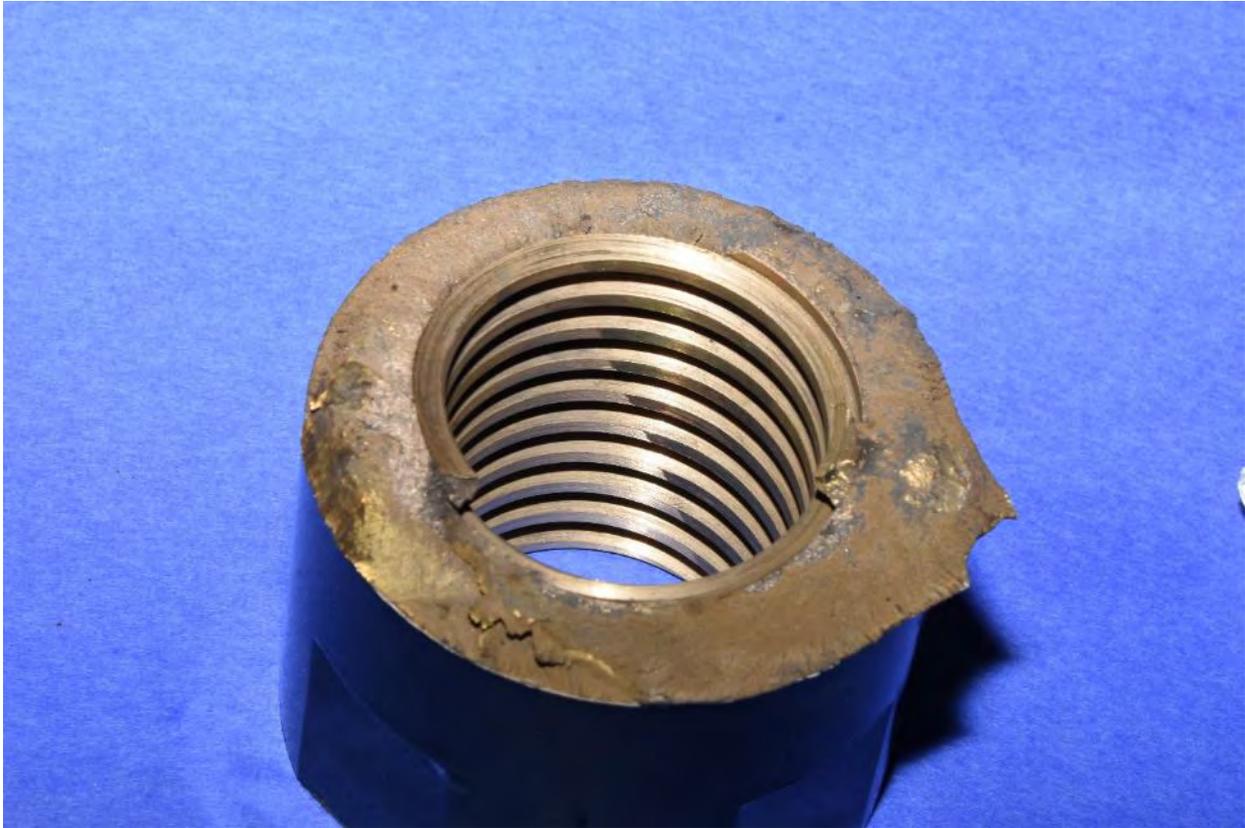
The portion of the right-side collar that had remained intact is shown in Figures 40 and 41 after removal from the threaded rod. The threads are in good condition and undamaged. This shows that the threads of the bronze collars had not worn down in service prior to the subject incident.

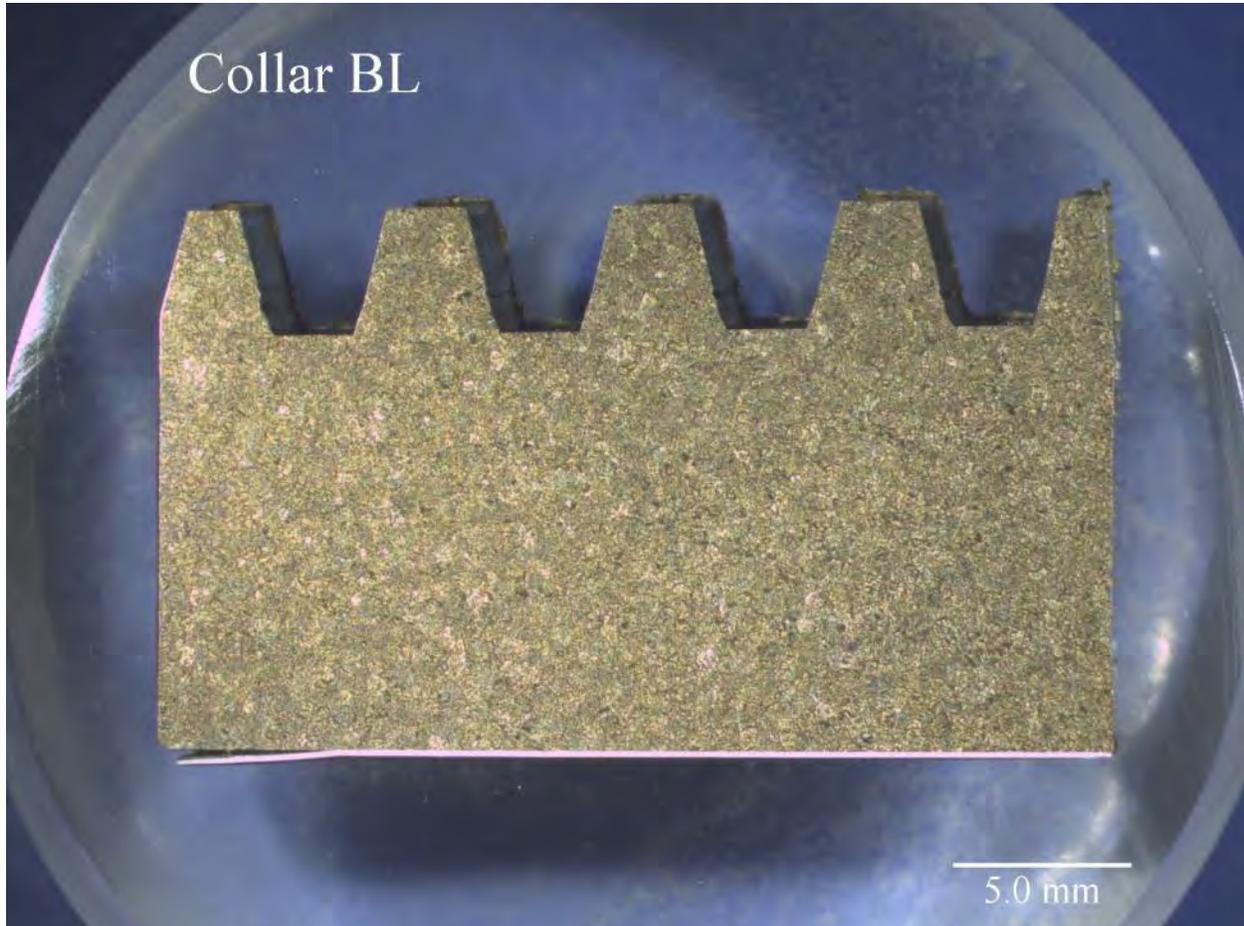
FIGURE 42

A section on a radial-axial plane was cut at the location indicated by the dashed red line on Figure 40 for metallographic examination. This section after mounting, polishing, and etching is shown in Figure 42. The thread profile shows no indication of significant wear. Higher magnification images in Figures 43 and 44 show typical microstructure for C954 cast aluminum bronze.

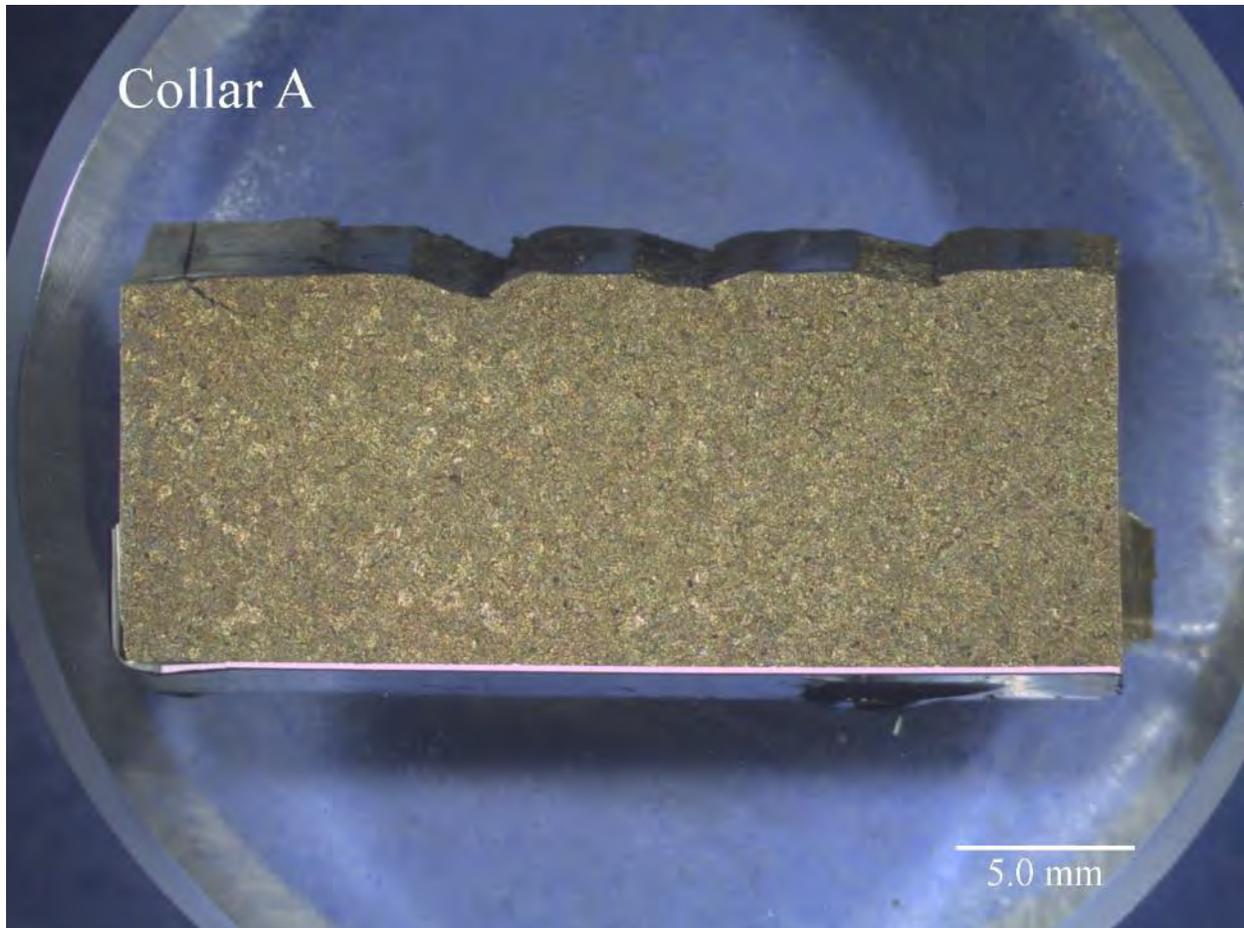
FIGURE 45

A section on the radial-axial plane indicated by the red X on Figure 20 was cut for metallographic examination of the sheared threads. This section after mounting, polishing, and etching is shown in Figure 45. Higher magnification images in Figures 46 and 47 show the tearing and shearing of the threads. The general microstructure of this collar is shown in Figures 48 and 49 and is also typical microstructure for C954 cast aluminum bronze.
