August 23, 2021

RE: NRT 21-11 Los Angeles, CA - TCV Failure Analysis  
File C21062

At your request I made an investigation to determine if the flanged collars on the threaded rods of the subject total containment vessel (TCV) failed suddenly as a onetime overload event or if they failed slowly over time and repeated use.

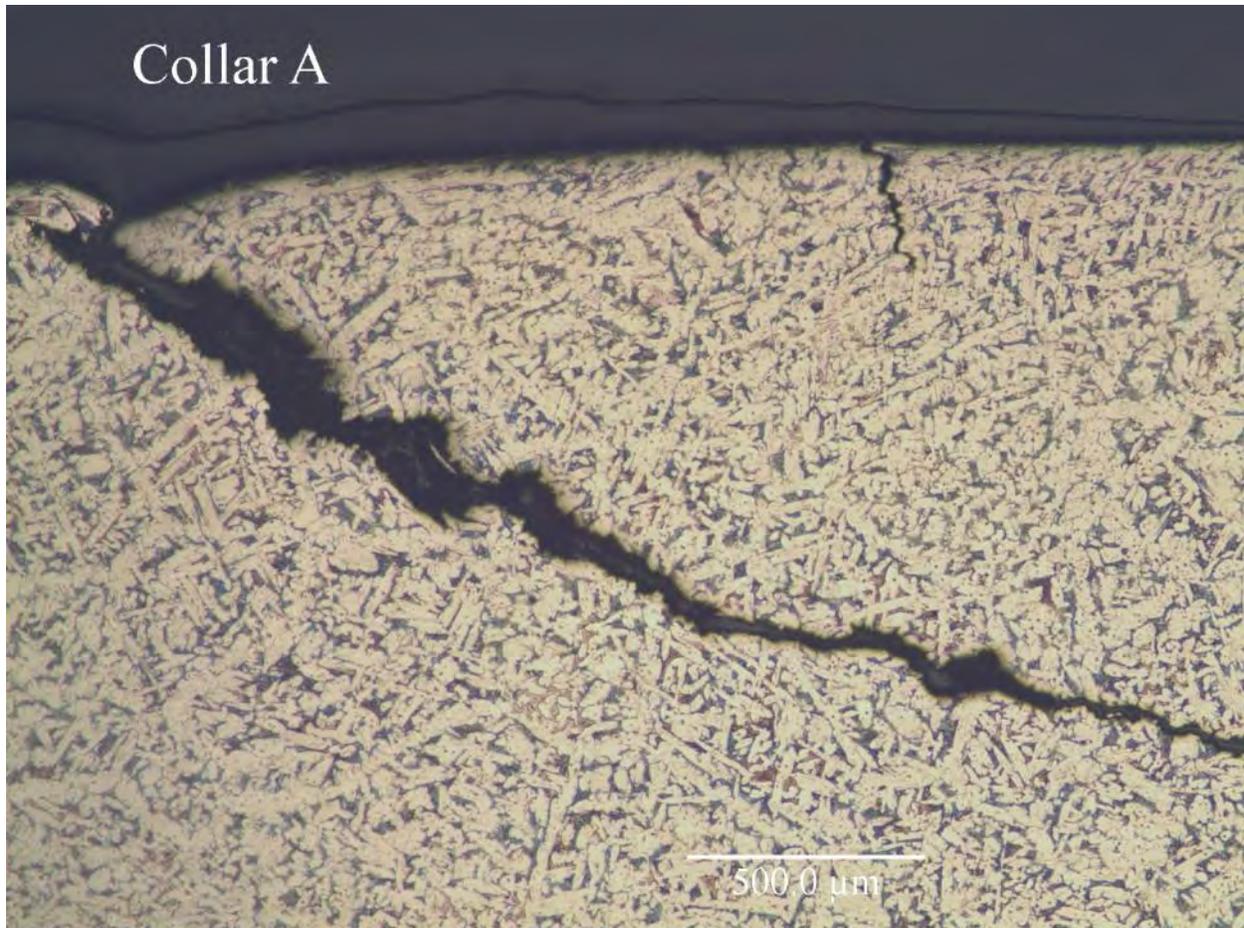
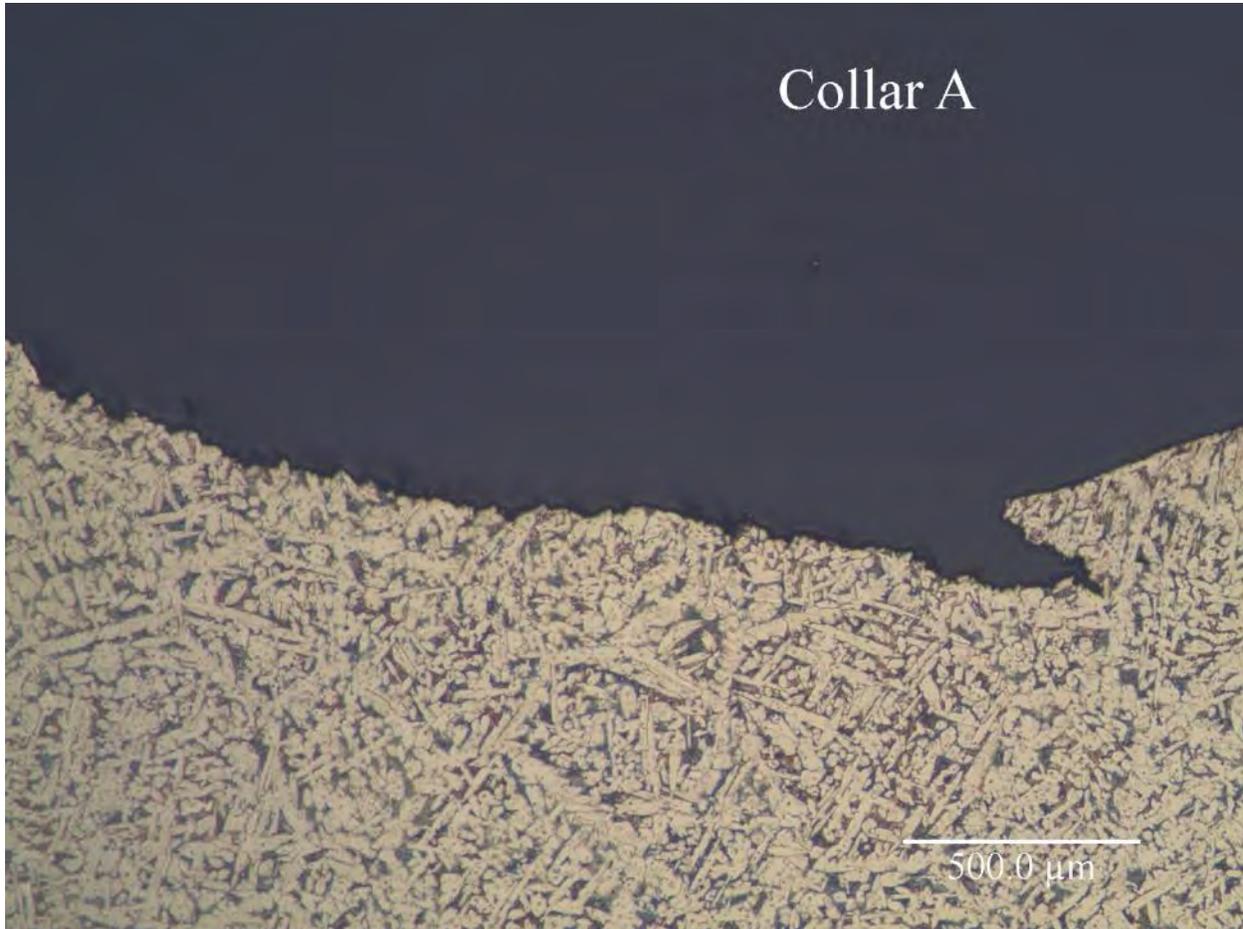
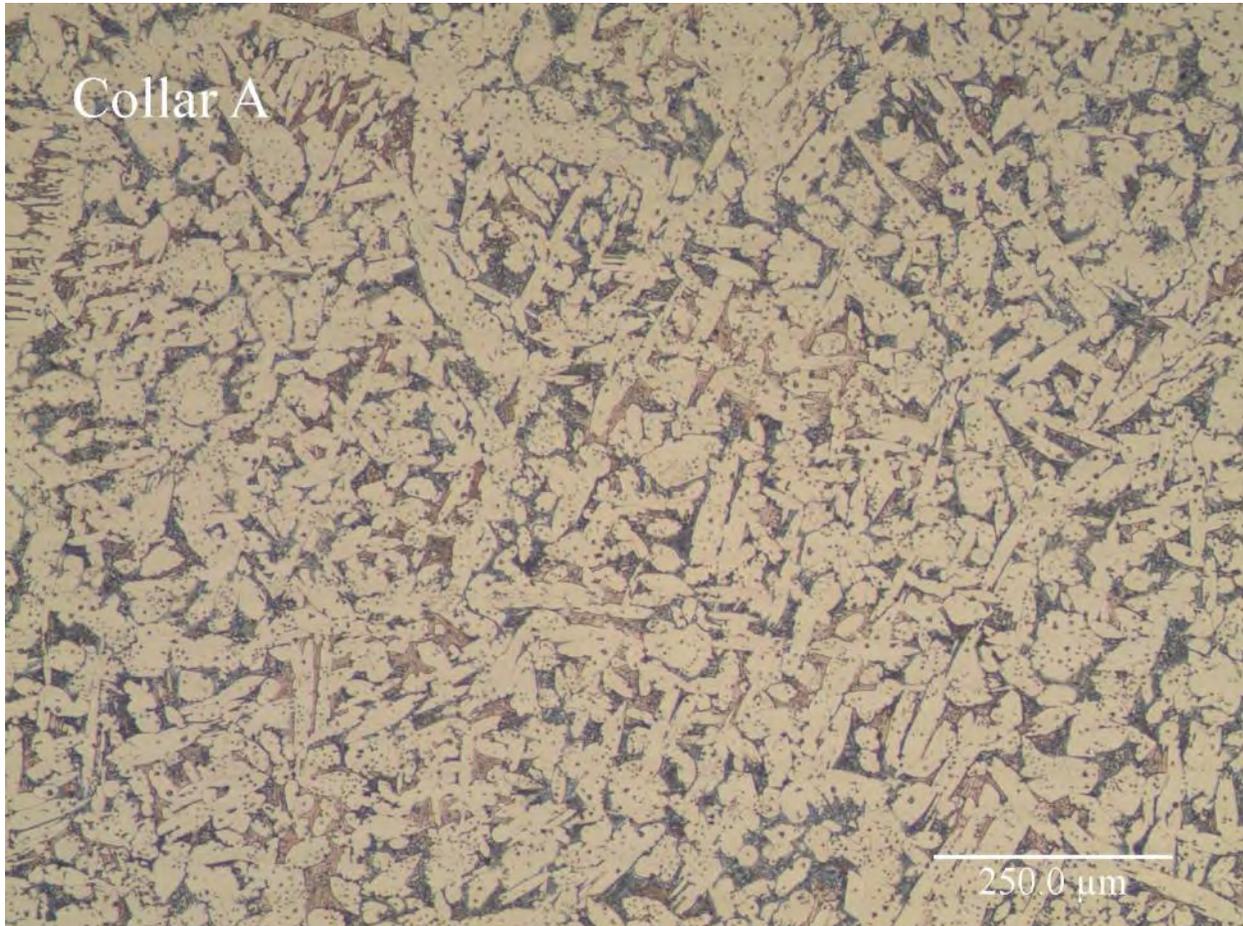
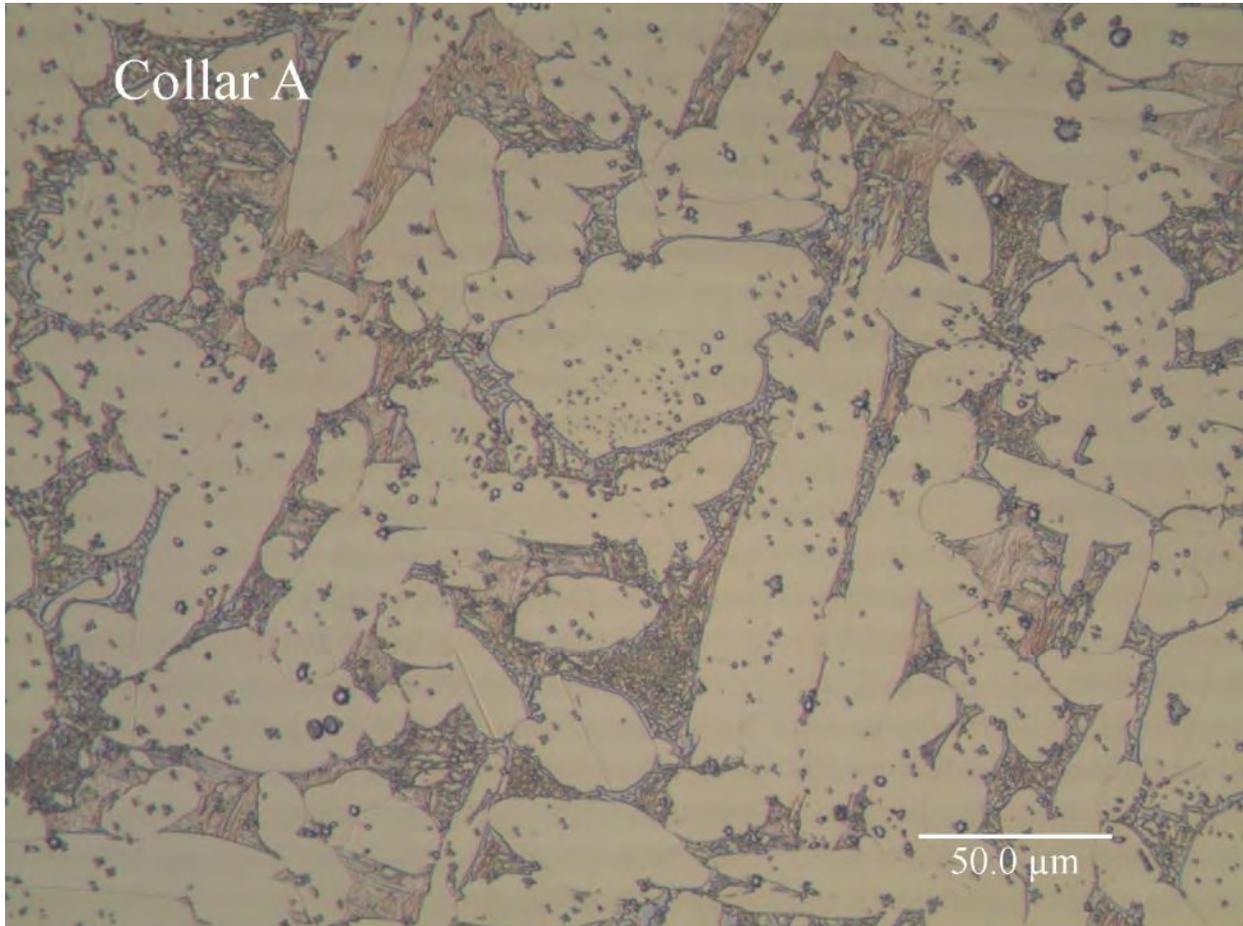
A section on the radial-axial plane indicated by the red X on Figure 20 was cut for metallographic examination of the sheared threads. This section after mounting, polishing, and etching is shown in Figure 45. Higher magnification images in Figures 46 and 47 show the tearing and shearing of the threads. The general microstructure of this collar is shown in Figures 48 and 49 and is also typical microstructure for C954 cast aluminum bronze.

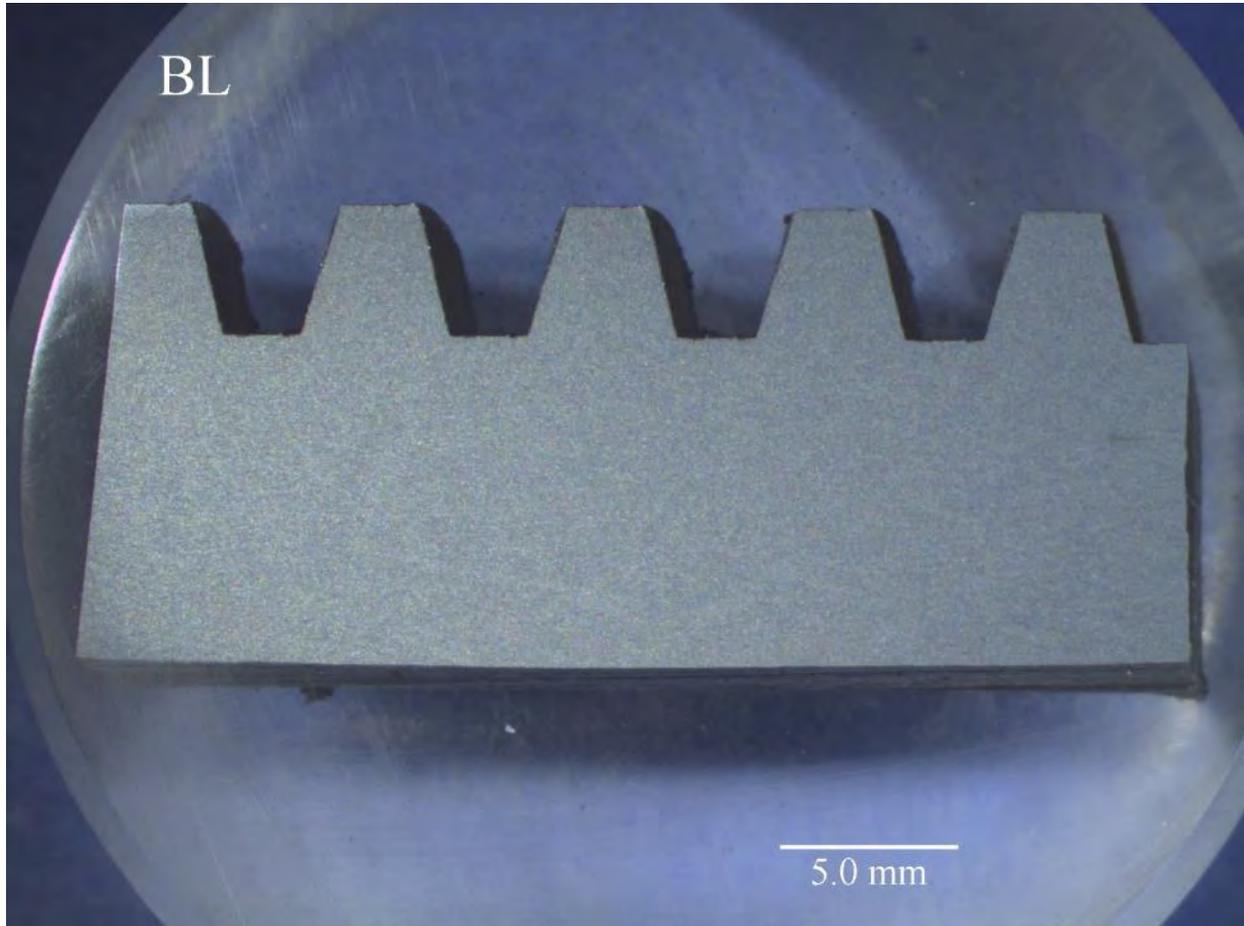
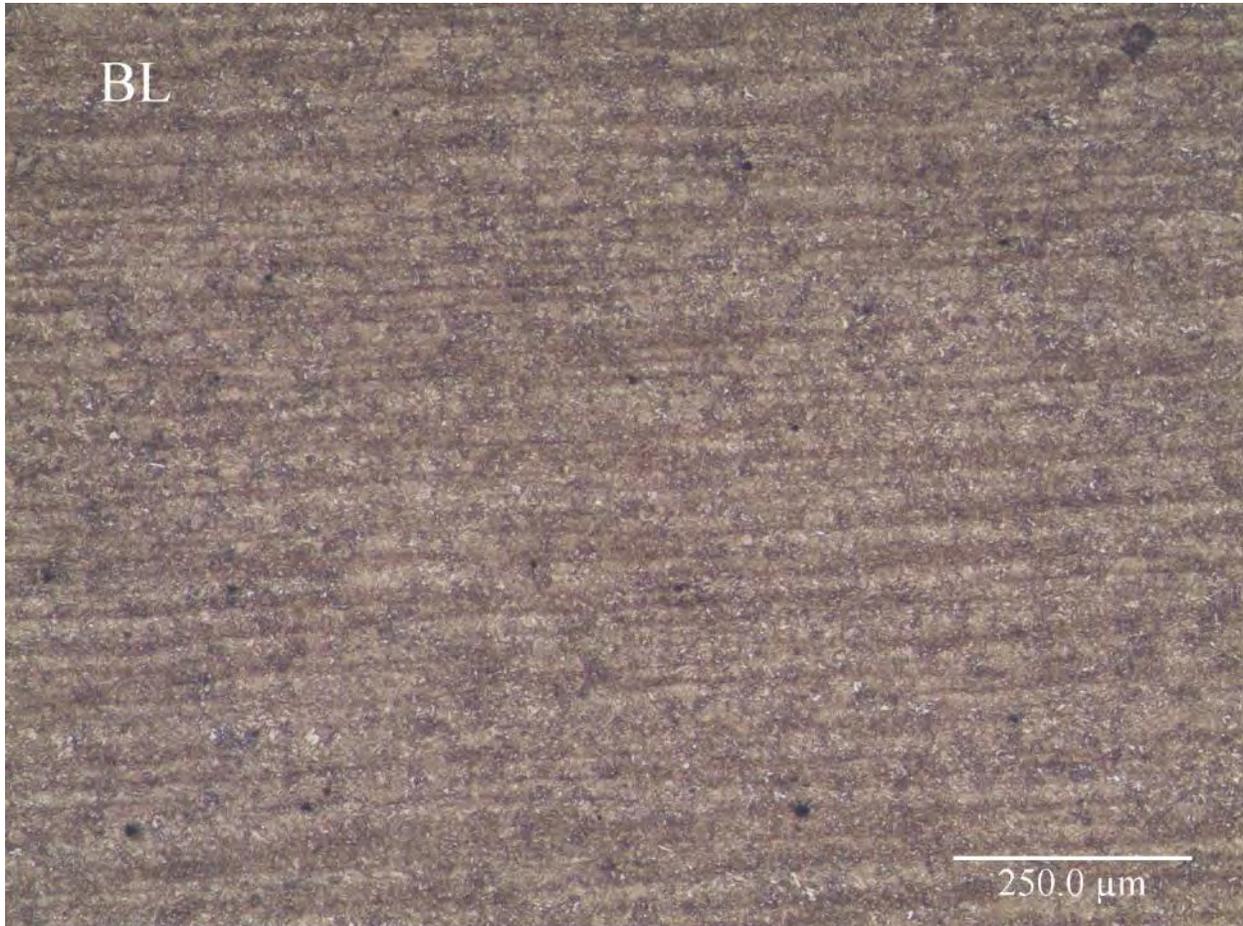
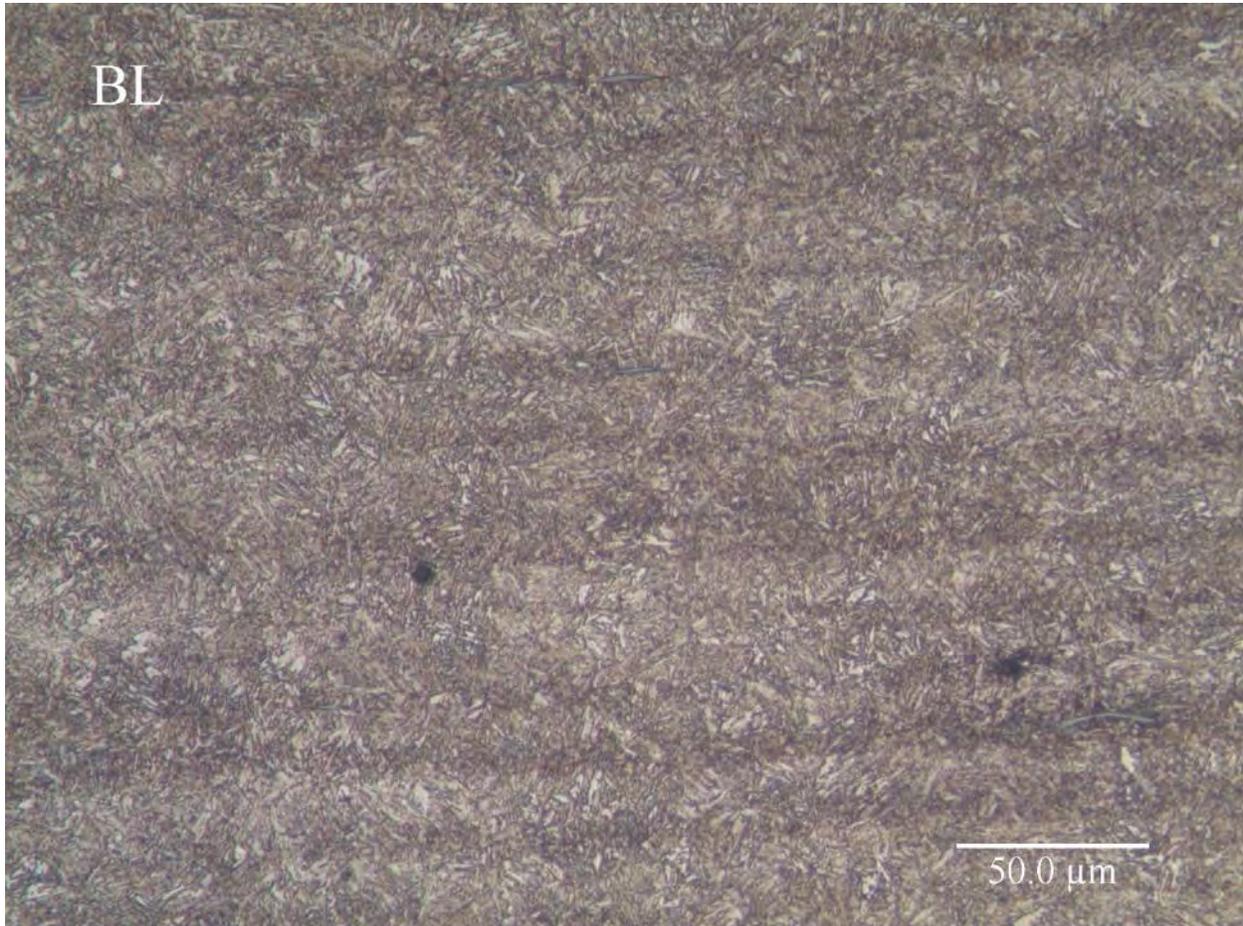
A radial-axial section through the steel threaded rod after mounting, polishing, and etching is shown in Figure 50. The higher magnification images in Figures 51 and 52 show typical microstructure for quenched and tempered alloy steel.

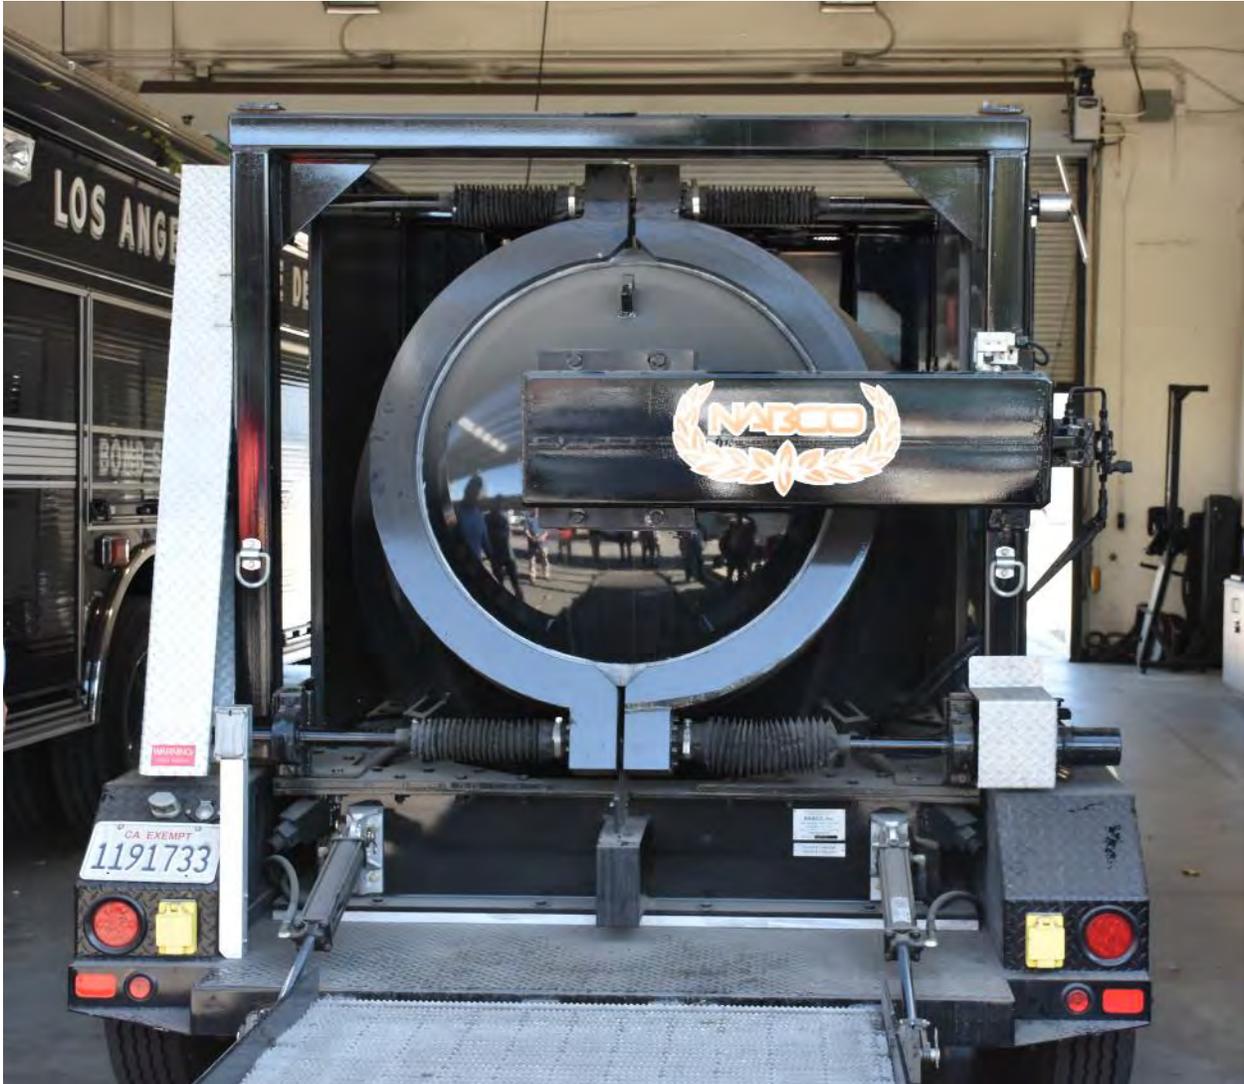
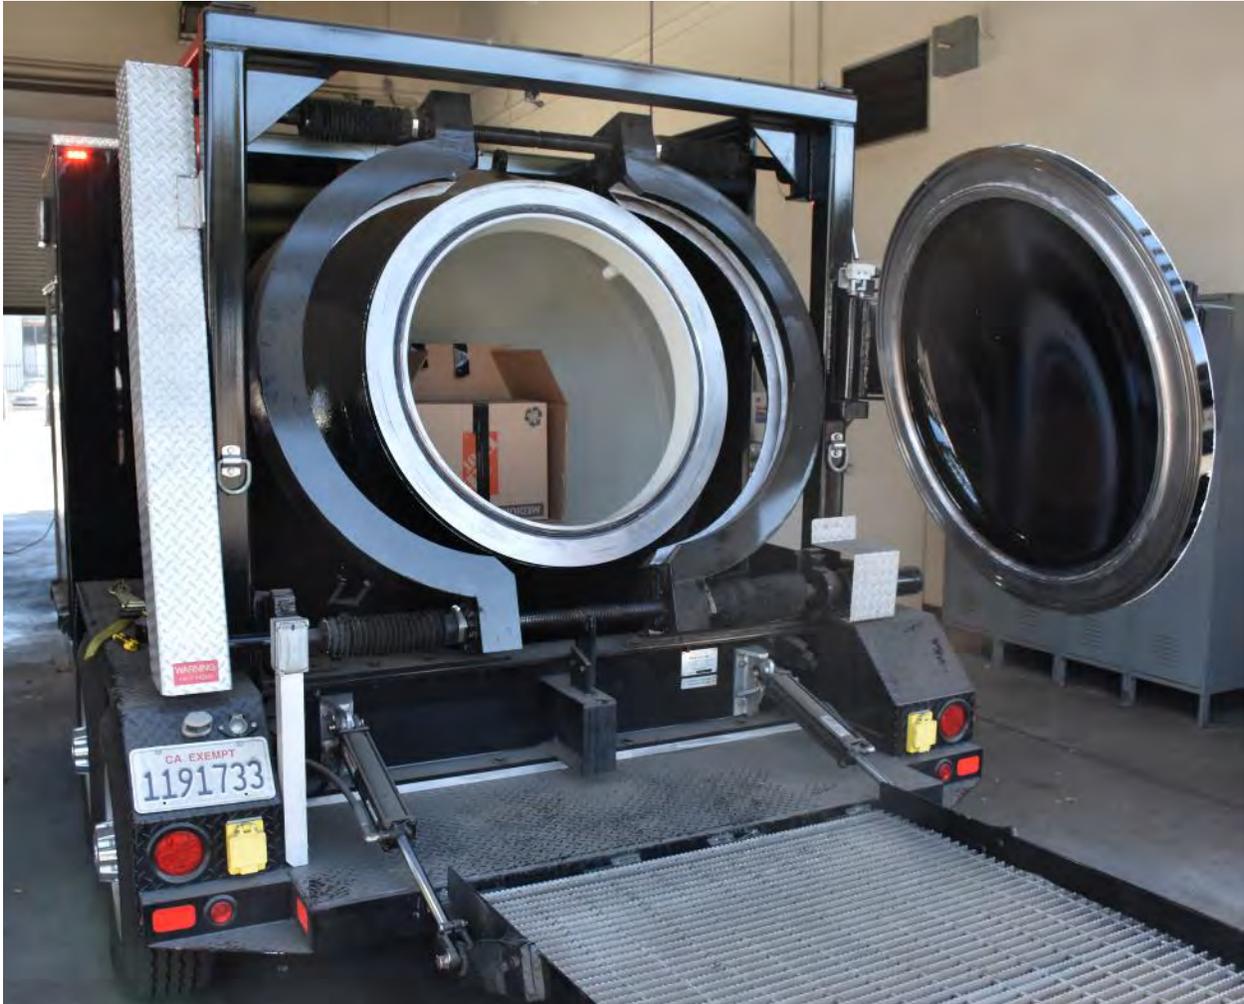
As mentioned above, I traveled to Los Angeles to examine damage to the threaded rods on another LAPD TCV. Photographs of this vessel by others are reproduced as Figures 53 and 54 with the door closed and opened, respectively. The yokes and rods had been removed as shown in Figure 55. After significant effort, a rod was removed as shown in Figure 56 to allow examination of the internal threads of a collar to determine the amount of wear.

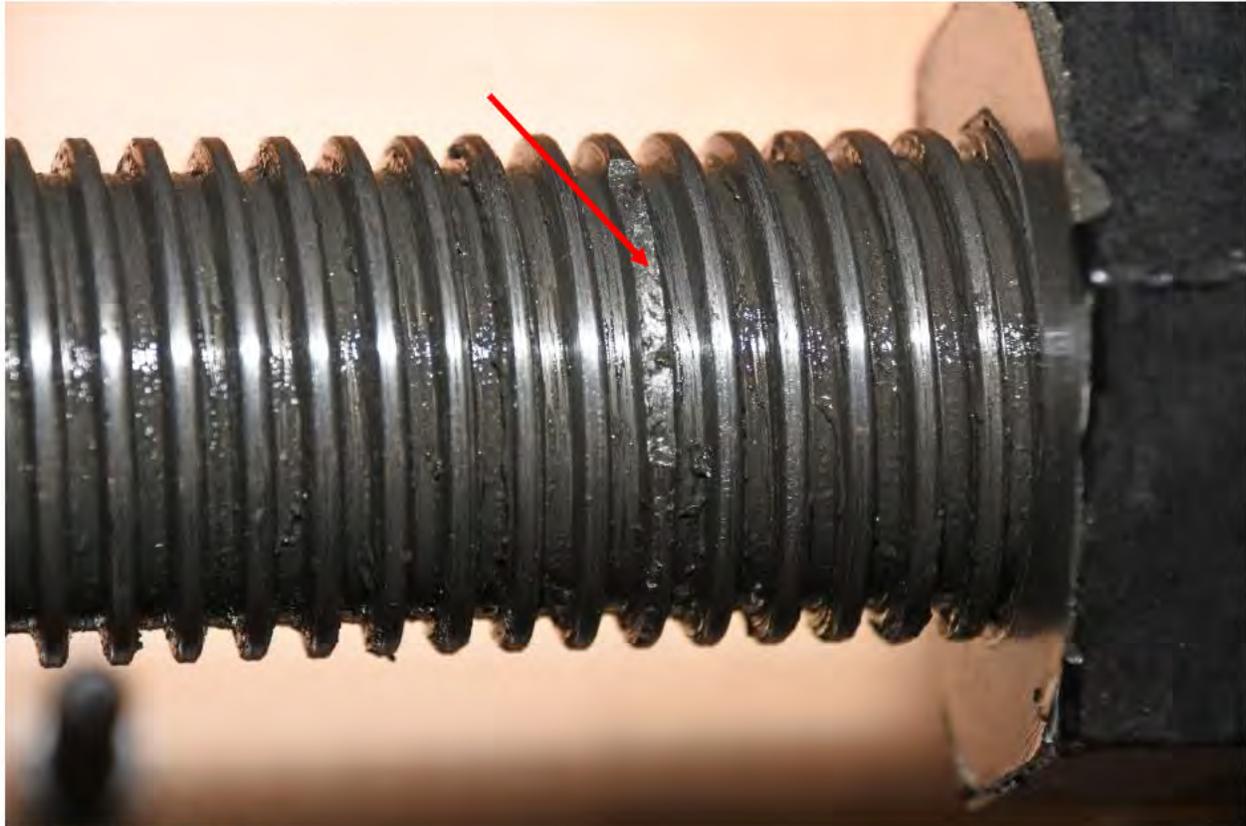
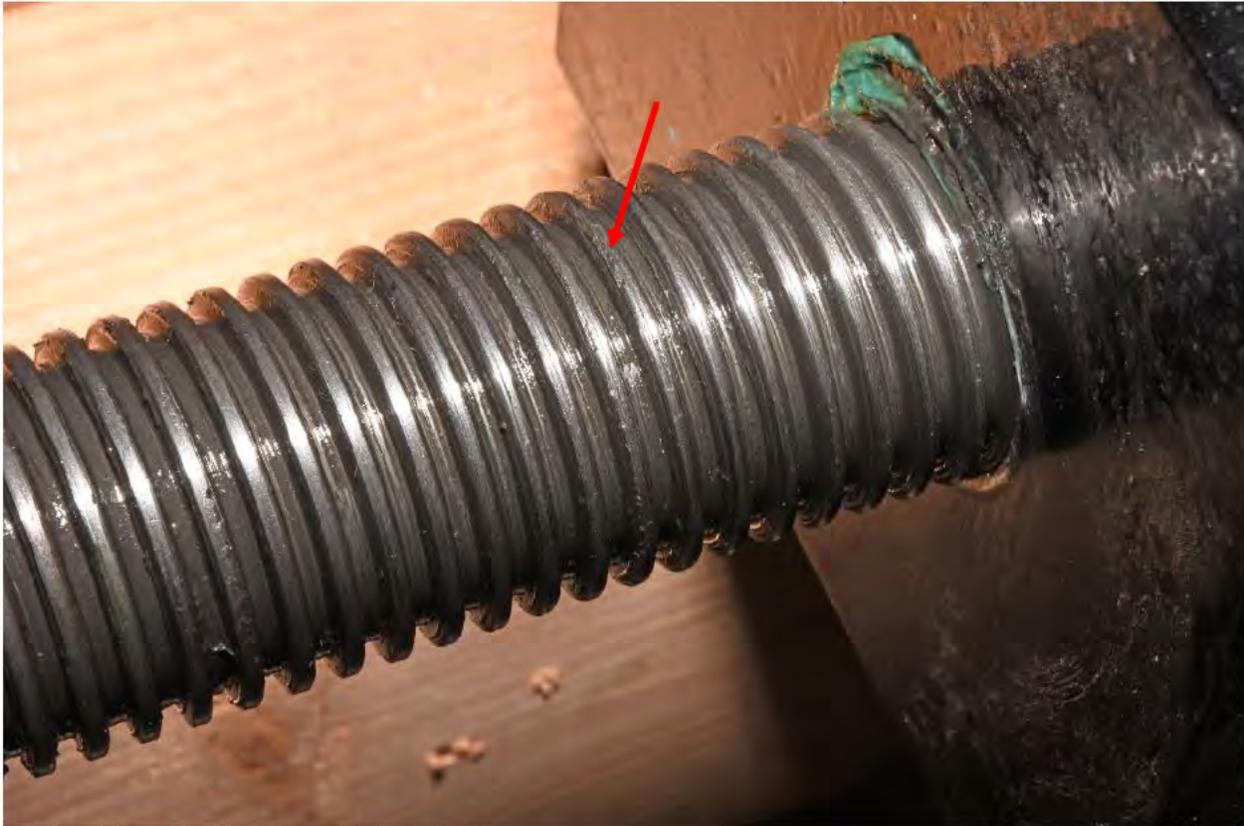
The damage to the threads of the steel rod is shown in Figures 57 and 58 (red arrows). This is galling type of damage caused by lubrication failure. It occurs when surfaces of metals that have a high coefficient of friction slide across each other under high load.

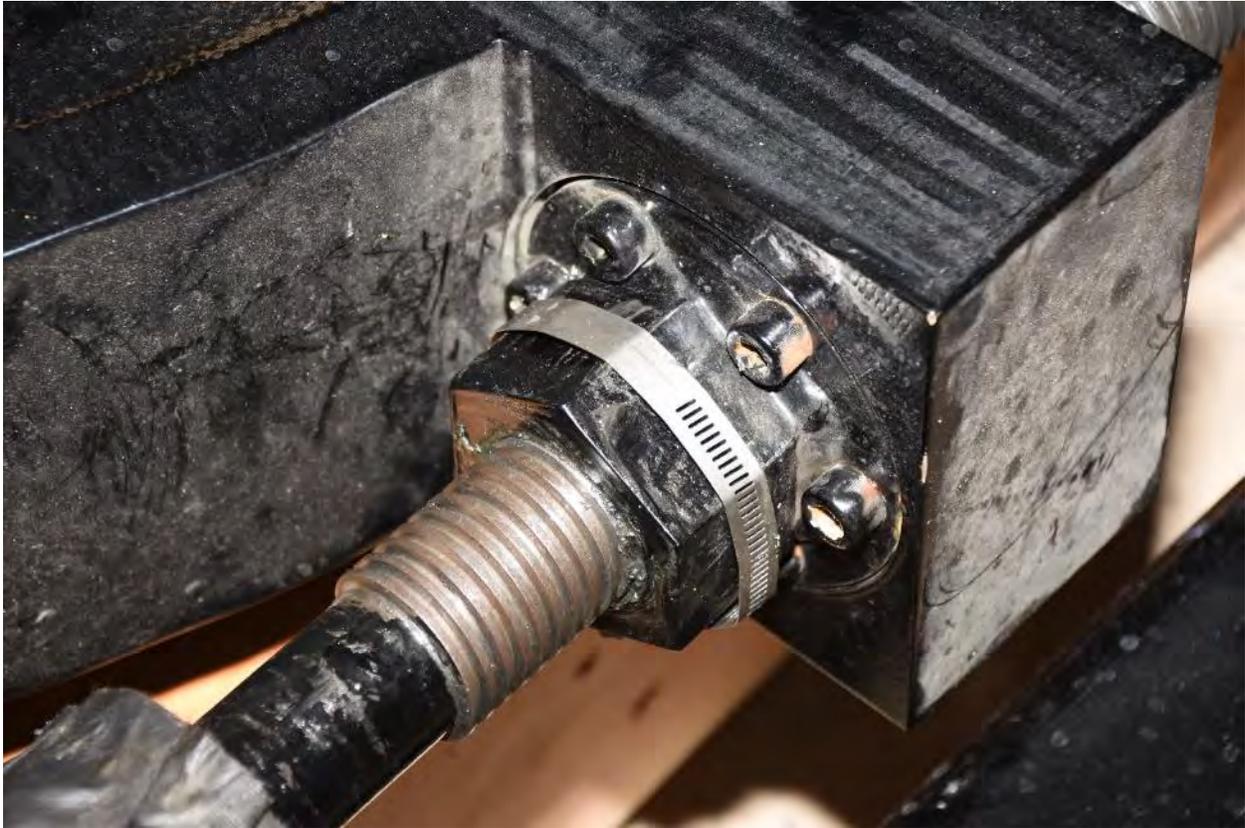
FIGURE 59

When the collar (see Figure 59) was removed it was determined that the collar was steel, not bronze as was the incident collar. Steel on steel is not a good combination for a rod and collar of a threaded drive. The coefficient of friction if lubrication breaks down is very high and galling can occur.

The exemplar vessel was older than the incident vessel. It appears that the manufacturer changed to bronze collars to address this problem.
