August 23, 2021

RE: NRT 21-11 Los Angeles, CA - TCV Failure Analysis  
File C21062

At your request I made an investigation to determine if the flanged collars on the threaded rods of the subject total containment vessel (TCV) failed suddenly as a onetime overload event or if they failed slowly over time and repeated use.

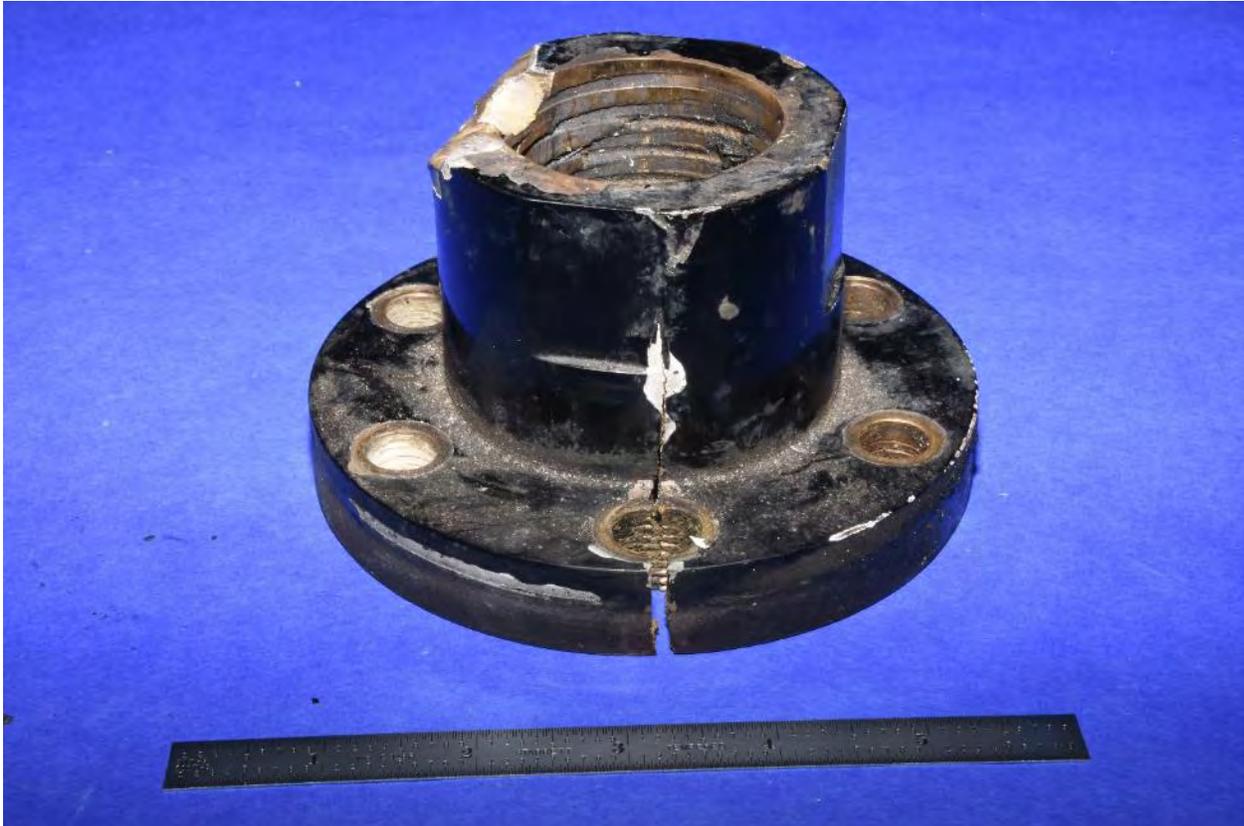
FIGURE 9

The lower threaded rod is shown in Figure 7. Figure 8 shows that the bronze threads of the left-side flanged collar have been sheared off and remain in the threads of the steel rod. Figure 9 shows that the right-side flanged collar has broken. The flange is broken away from the rest of the collar. The threads that had been inboard of the flange have been shear off and remain in the mating threads of the steel rod. The threads of the remainder of the collar are still intact and that portion of the collar turns freely on the steel threaded rod. The flanged collar that had been attached to the bottom of left side yoke (based on site photographs) is shown in Figures 10 and 11. All the threads have been sheared from this collar and the collar has a crack on a radial-axial plane through one of the bolt holes.

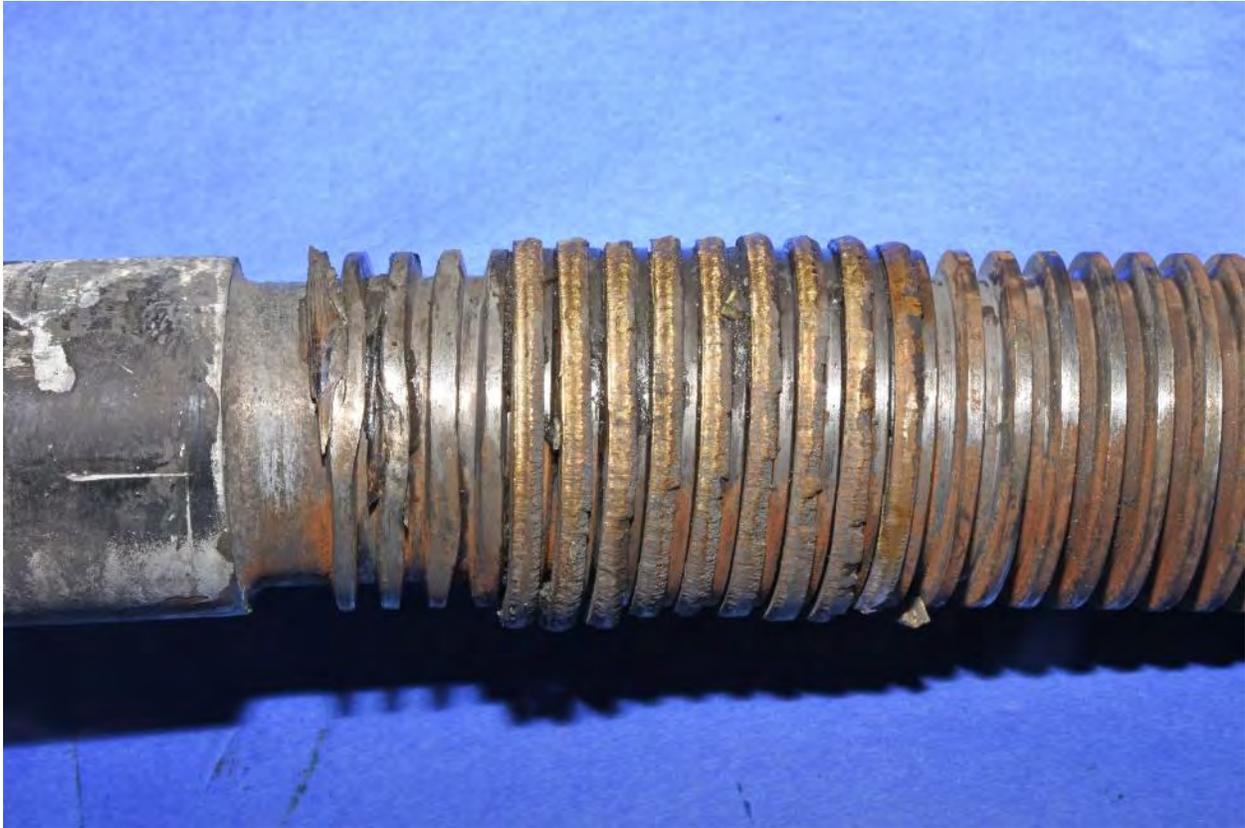
FIGURE 35

The removed section of the bottom threaded rod after degreasing is shown in Figure 35. The sheared off collar threads are visible. The distance between where the threads were sheared off is consistent with the yokes having been in the fully closed position when this occurred. The threads which sheared off the left-side flanged collar are shown in Figures 36 and 37. The threads which had sheared off from the flange on the right-side are shown in Figures 38 and 39. This type of shear failure of entire threads does not occur slowly over time; it occurs as a rapid onetime event. The longitudinal break in the threads visible in Figure 37 shows that the longitudinal cracking of the collar occurred slightly before the threads were completely sheared off.
